# Determination 2023/015

**Regarding the decision to issue a code compliance certificate for the construction of the foundation and floor slab of a vehicle storage and maintenance shed**

**2 to 6 Bidois Road, Fairy Springs, Rotorua**

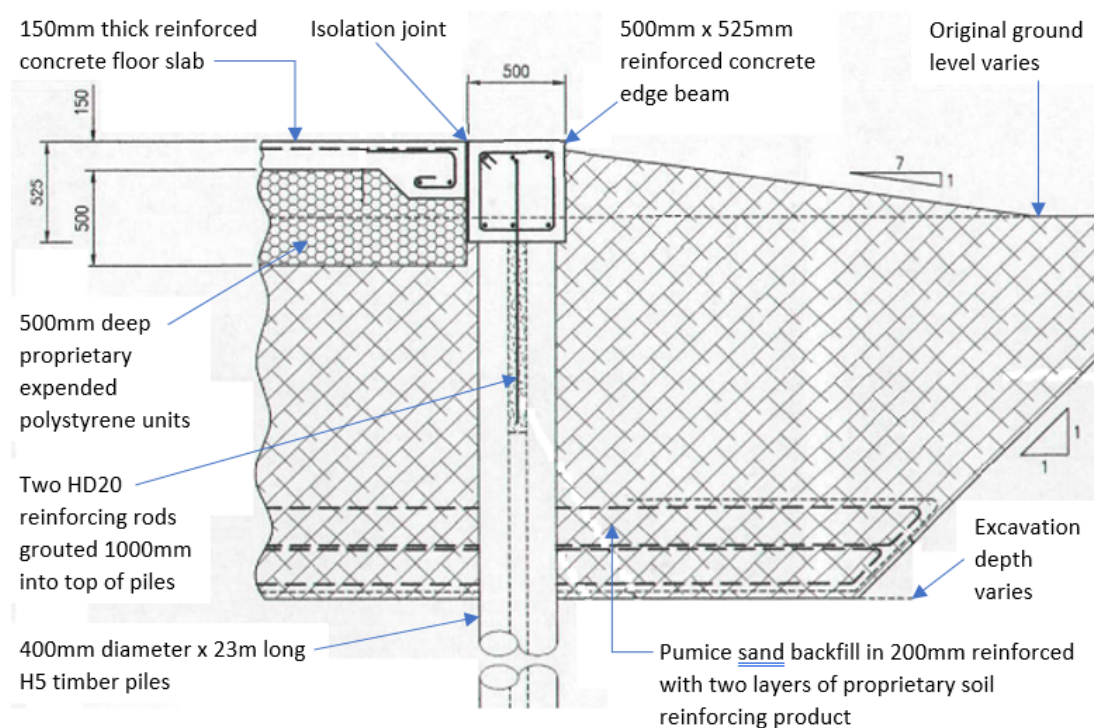
**Figure 3: Foundation system and floor slab (not to scale)**

- 2.11. The floor slab is supported on a 500mm deep layer of proprietary expanded polystyrene units covered in a minimum 1mm thick flexible high density polyethylene membrane. Under these units is a variable depth of “pumice sand backfill compacted to 95 percent of maximum dry density at [an] optimum moisture content and less than 10 percent air voids in 200mm [maximum] layers”, reinforced with two layers of a proprietary geotextile product used to strengthen soil. The consented design specified that the backfill was to extend between 4.2m to 5.6m beyond the perimeter of the

truck shed, with the top surface sloped downwards and away from the “edge beam”.<sup>22</sup> Refer to figure 3.

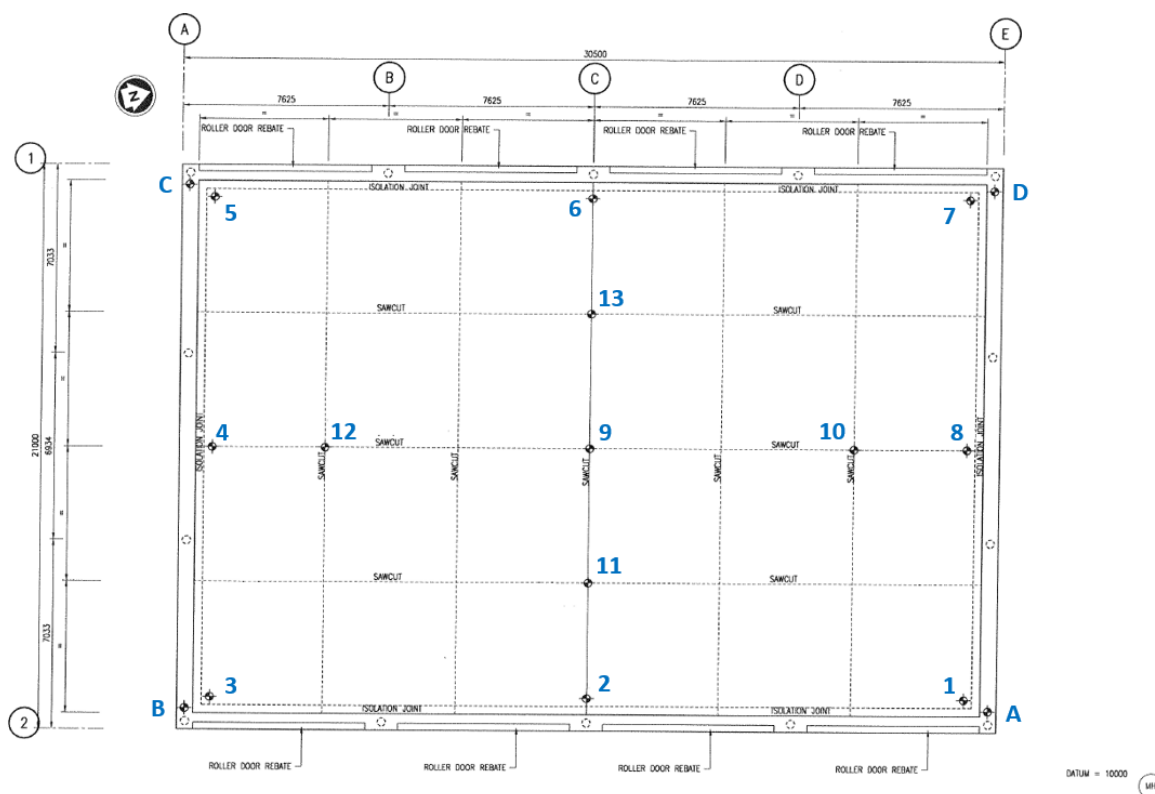
**Figure 4: Location of survey points (not to scale).**

3.19. Several settlement monitoring surveys were carried out by engineer 2 between 3 July 2015 (the initial survey) and 17 November 2015.<sup>42</sup> The survey measured four points on the top of the perimeter edge beam at the corners of the truck shed, and 13 reference points spaced at different locations across the floor slab. Refer to figure 4.

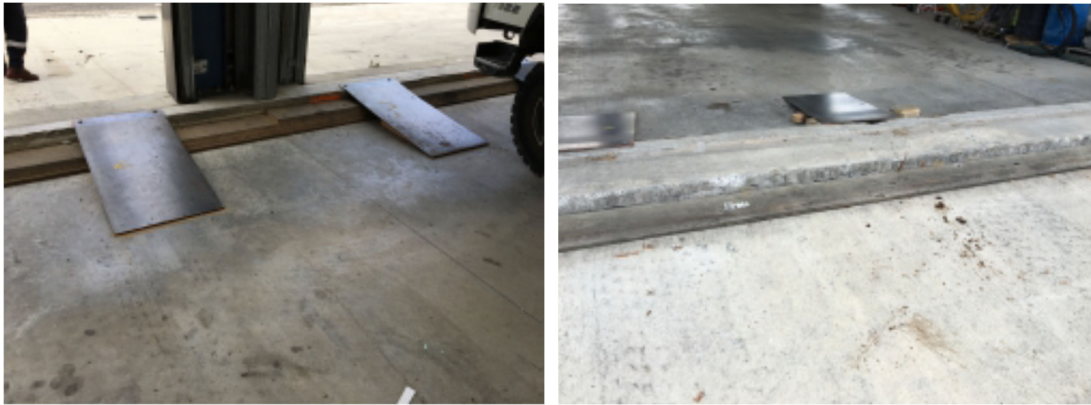
- [Engineer 1 considers] that ongoing settlement may now be mainly due to secondary creep in the organic soils only.
- 3.29. Incident reports from the company leasing the truck shed, dated 21 November 2019 and 2 June 2020, indicate damage being caused to vehicles accessing or exiting the truck shed because of the settlement of the floor slab. Photographs attached to the report from 2 June 2020 show that steel plates have been fixed in place to allow for the movement of vehicles over the perimeter edge beam due to the lower-level floor slab and external concrete hardstanding. Refer to figure 5.

(Note: Photograph 5(b) indicates damage to the exposed top corners of the perimeter edge beam).

- 4.2.15. Damage has occurred to the door sill parts of the perimeter edge beam from vehicle movements due to the settlement of the floor slab generating a non-trafficable surface at the floor slab to perimeter edge beam junction through the truck shed doorway entrance.

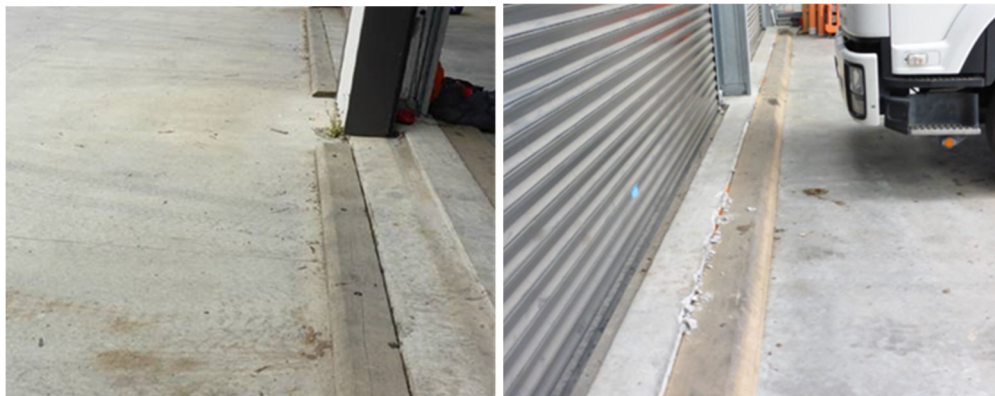
### **Figure 6: Vehicle access door to the southeast corner of the truck shed.**

- 4.1.12. Photographs which showed “timber chocks...placed on both sides of the [vehicle access] doors as a temporary measure so...trucks could climb over the door sills”. Refer to figure 6. The owner stated the timber chocks have now been replaced with “steel plates to reduce the steepness of the climb into and out of the [truck] shed”. Refer to figure 5(a).

(a) Timber chock inside the shed      (b) Timber chock outside the shed
