# Determination 2024/006

**The refusal to issue a certificate of acceptance for building work associated with a dwelling**

**73A Gledstane Road, Stanmore Bay, Whangaparāoa**

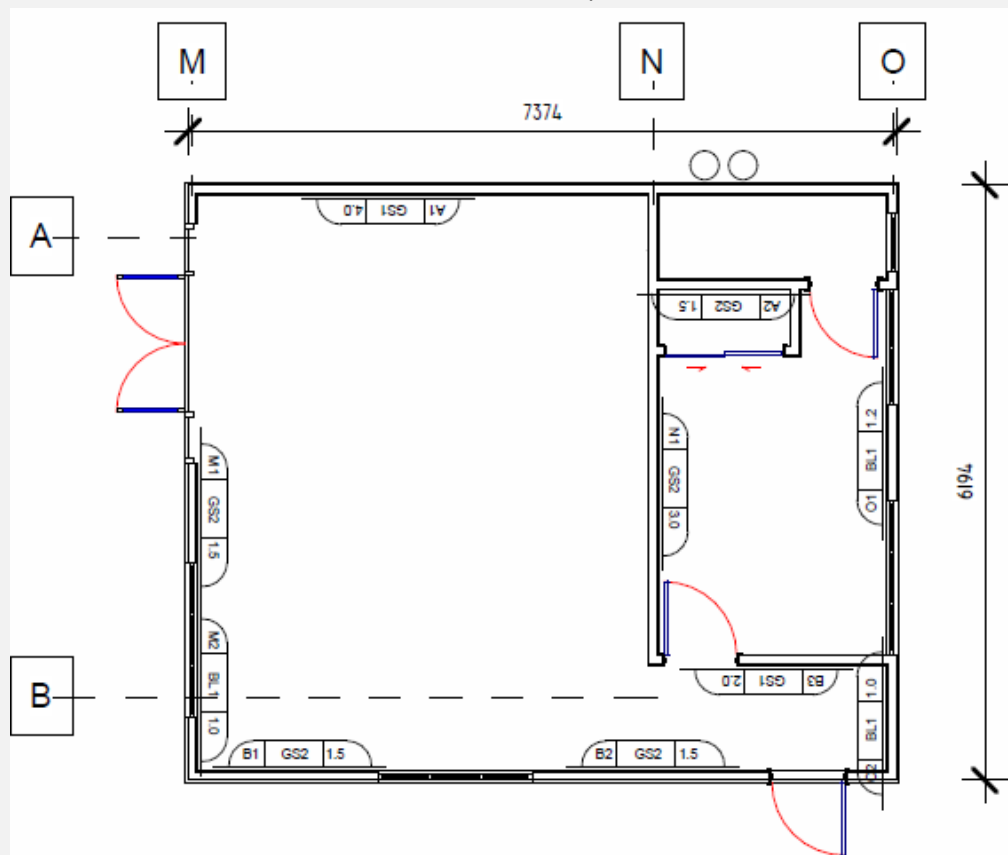
Figure 2: As-built bracing plan copied from Sheet A201, dated 07/11/21 (not to scale).

- Elements M1, B1 and B2 are located on the external walls, and are noted as GS2 bracing elements. GS2 bracing elements require GIB lining to be installed to both sides of the framing. No evidence has been provided to confirm that these bracing elements are GS2s. Given the location of these elements on the external walls (of the type installed in this building), I consider it is unlikely that these bracing elements are GS2s.

- As such, I am not satisfied that the bracing plan and associated calculations accurately reflect what has been installed on site. I also note that the BL1 elements (at M2, O1 and O2) require a specific hold down fixture, which would have needed to be verified with specific evidence.

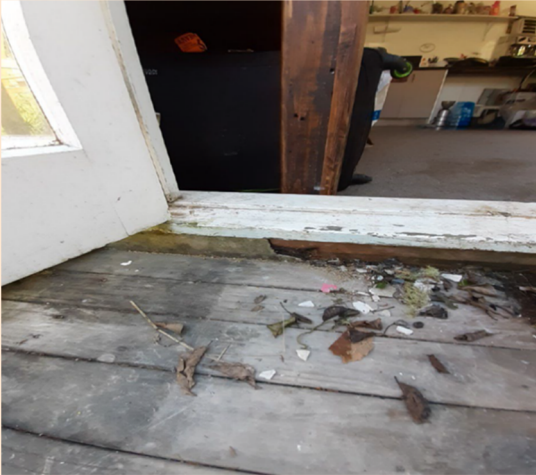
<b>Clause E2 External moisture: In terms of cladding system and the deck to cladding junction</b>	
Authority’s view	<p>The refusal report noted:</p> <ul style="list-style-type: none"> <li>Plan A104 states “All exterior wall cladding material bevel back aluminium direct fixed complying with E2/AS1”. However, at the inspection, the authority sighted “profile metal cladding as consistent with garage cladding circa 2006”.<sup>28</sup></li> </ul> <p>The refusal report included:</p> <ul style="list-style-type: none"> <li>A photo showing the cladding.</li> <li>A photo showing the junction between the cladding and deck (see Figure 3). The photo was captioned “No wash down 12mm between primary structure &amp; Deck”.<sup>[29][30]</sup></li> </ul>

<sup>30</sup> In reference to this photo in its determination submission, the authority also noted the bottom plate is exposed.

<p><b>Figure 3: Photograph of deck to cladding junction</b></p>
Owner's view	<ul style="list-style-type: none"> <li>• The 'building code compliance report' noted "Ground clearances, cladding overlaps, window flashings, penetration sealing, appear adequate, with no indication of likely moisture penetration. The clearances are adequate, and the exterior offers no indication of any problems".</li> <li>• The owner's determination submission noted "To our knowledge the cladding is aluminium, and typically used as a cladding material along with formed metal for the era, once again this was never queried in any RFI". The owner also provided a photo which indicates there is building wrap beneath the cladding.</li> </ul>
Ministry's conclusion	<p>In regards to the cladding, I note that:</p> <ul style="list-style-type: none"> <li>• From the information provided, it is unclear whether the cladding is "bevel back aluminium" or another type of profiled metal cladding. In regards to the owner's comment that "To our knowledge the cladding is aluminium...", I do not consider this is sufficient confirmation of the type of cladding.</li> <li>• Further, the only information provided about the compliance of the cladding is the note on the elevation plan (Sheet 104, dated 07/11/21 and revised 05/03/22) stating "All exterior wall cladding material bevel back aluminium direct fixed complying with E2/AS1".</li> <li>• E2/AS1 states "Horizontal profiled metal wall cladding shall be fixed over a drained cavity...".<sup>31</sup> However, the owner states that the cladding is "direct fixed" (ie not installed over a cavity). As such, it does not comply with clause E2 by way of Acceptable Solution E2/AS1.</li> <li>• Performance clause E2.3.2 states "Roofs and exterior walls must prevent the penetration of water that could cause undue dampness, damage to building elements, or both". In my view, the owner has not provided sufficient evidence to demonstrate compliance with E2.3.2 by way of an alternative solution.</li> <li>• While this may be a valid reason for refusal, the reason provided by the authority in the refusal report was not specific enough in terms of Building</li> </ul>
