Determination 2018/066

Regarding the authority's decision to issue a code compliance certificate for alterations to a relocated house at 6984F State Highway 1, Pakaraka, Moerewa

This determination considers the issue of a code compliance certificate for alterations to a relocated house. The determination discusses the compliance of the building work with the building consent and with relevant clauses of the Building Code.

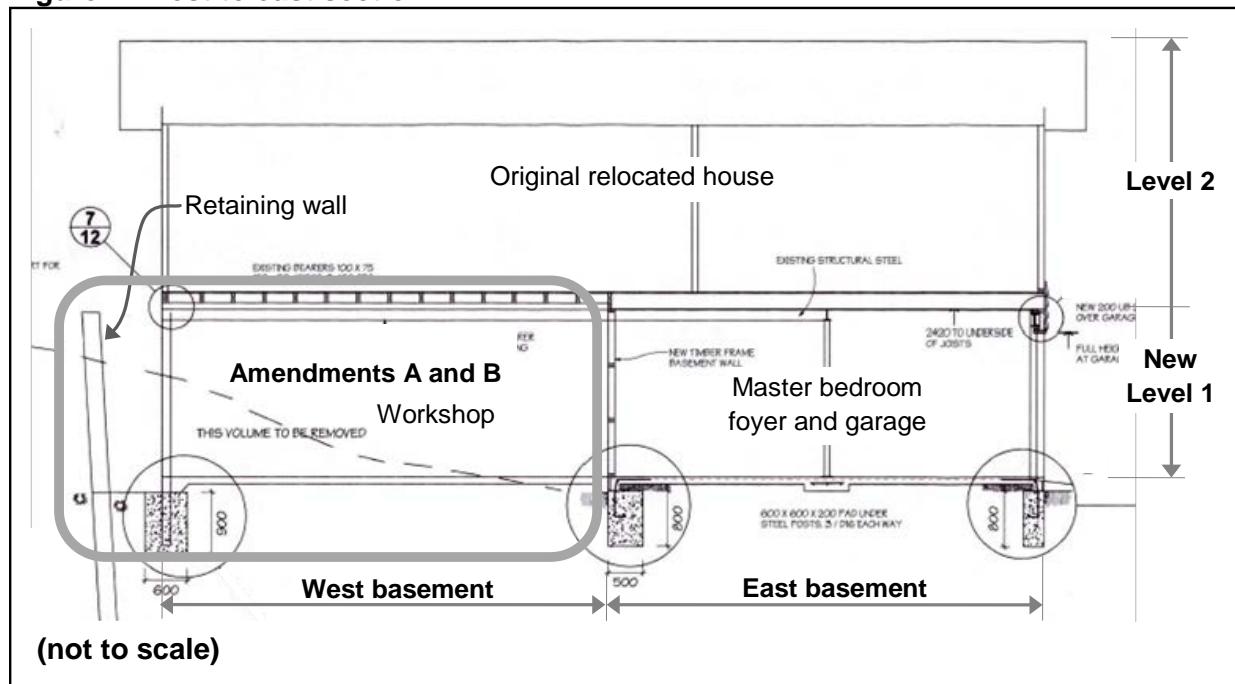
Figure 1: West to east section

2.3.1 As shown in the sketch in Figure 2, alterations included new retaining walls to the west and south, the addition of a basement workshop area to the west, a new deck to the south, extension of the upper level lounge to the north and east, an entry canopy to the east and extensive interior alterations to the upper floor.

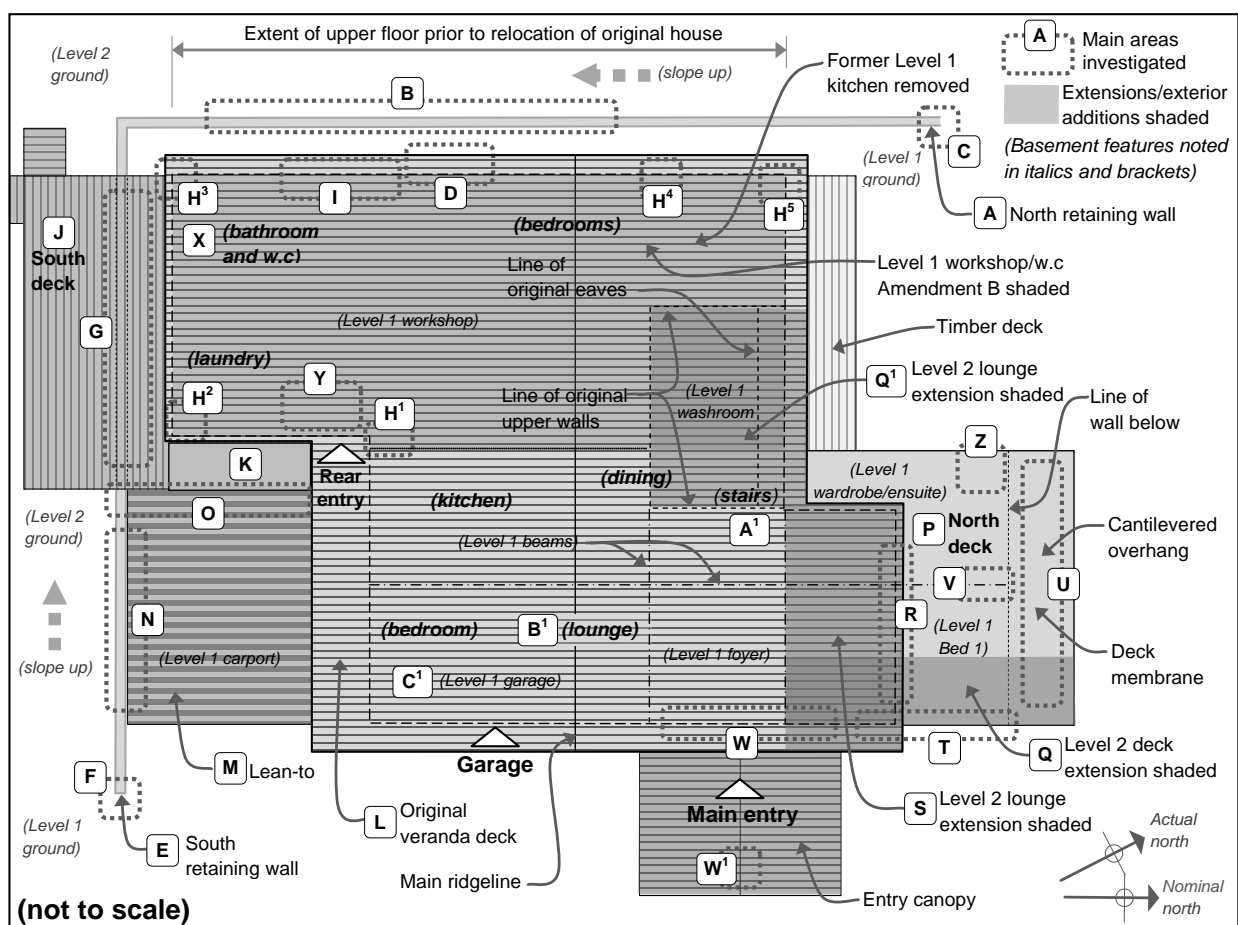
Figure 2: Approximate plan

2.3.2 There is no as-built floor plan of the upper level but, based on inspection photographs and records, the house now appears to accommodate the following:

- Level 1 (the new basement level): the main entry canopy, with:
 - entry foyer with stairs to the upper level (Area A¹)
 - a garage to the southwest (Area C¹)
 - master bedroom and ensuite to the north beneath the north deck
 - workshop and washroom to the west.
- Level 2 (the upper level): the stairs landing in the living area, with:
 - lounge/dining areas to the north, opening onto the north deck, with extensions into the dining recess (Area Q¹) and above the master bedroom (Area S)
 - the north deck, expanded to the west above the master bedroom (Area Q)
 - a new deck (Area J) extended over the south retaining wall (Area G), with a return walkway to the east (Area K)

- bedroom to the southeast, opening onto the original south veranda (Area L)
 - laundry (Area Y) and rear entry from the original veranda (Area L)
 - bathroom and toilet facilities to the southwest (Area X)

- two bedrooms to the west
 - a lean-to carport structure to the southeast corner (Area M).
- 2.3.3 Construction of Level 1 is a mix of conventional light timber frame and specifically engineered post piles with infill timber framing, concrete slabs and foundations, and posts and beams. Level 1 has a mix of original and new timber framed partitions and the original particle board flooring. The corrugated steel roof cladding appears to be a mix of original roofing and new roofing over the lounge extension.
