Determination 2021/012

Regarding alterations to install insulation in a skillion roof at 96 Lochiel Branxholme Road, Lochiel, Winton

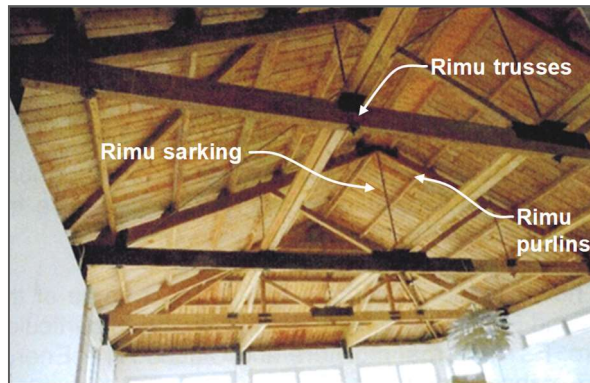
Figure 1: Original roofing timbers

- roofing installed directly over the underlay, which was stapled onto the plywood sarking and appeared to be satisfactorily installed
- plywood nailed through a 10mm batten installed over the roof purlins, with uPVC⁷ jointers at vertical joints and horizontal butt joints
- visible black stains on the underside of the north east but not the south west plywood
- 80mm insulation board ‘loosely laid’ between purlins with some large gaps
- the use of expanding foam to various gaps
- wrinkling to the top paper and the foil underside of the insulation board
- moisture staining to the underside of the Rimu boards to the northern end.

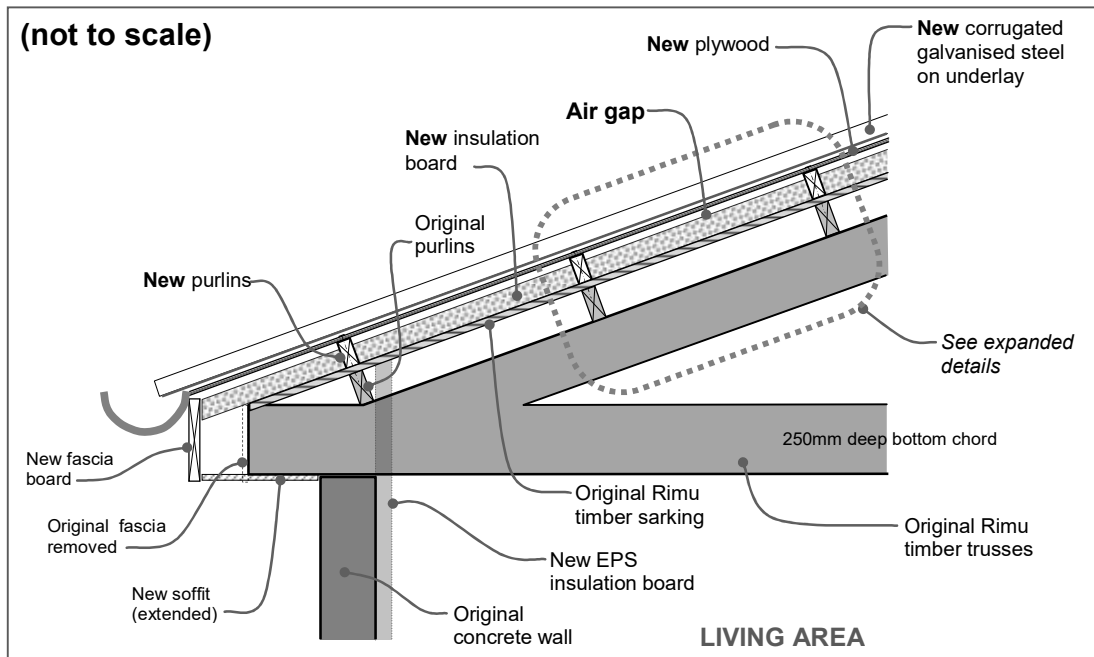
Figure 4: Typical section

2.3.2 Figure 4 shows the general construction of the new skillion roof above the original timber sarking, with the original rimu timber trusses and sarking left exposed as shown in Figure 1. Expanded details are provided in Figures 5A and 5B.

- In regard to this 2011 skillion roof design (see Figures 4 and 5):
 - Tongue-in-groove timber ceiling linings allow moisture vapour through the joints.

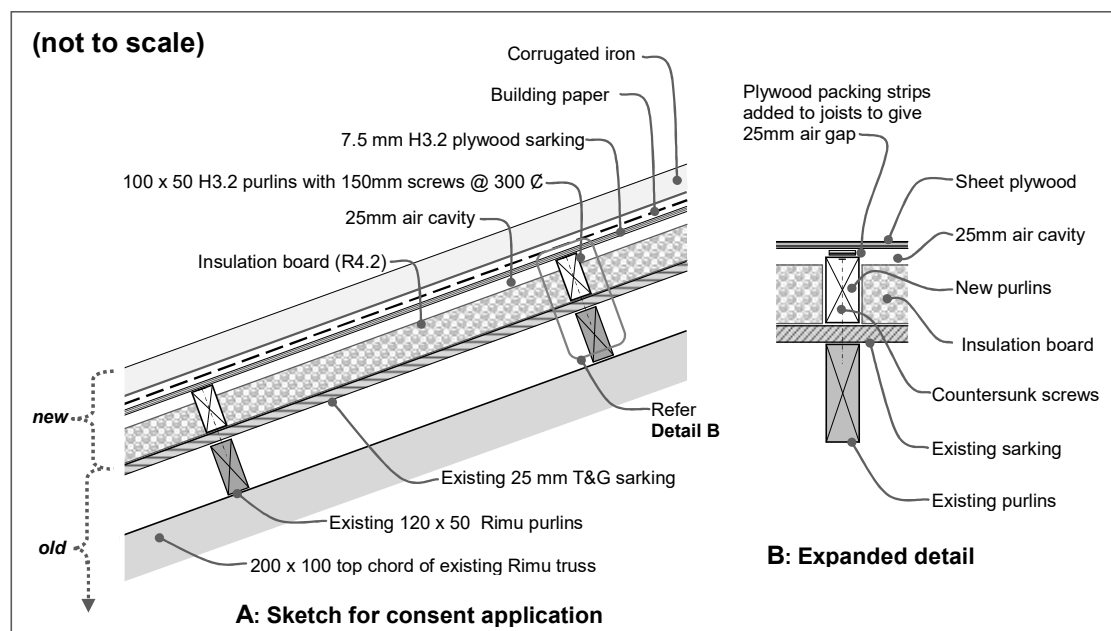
Figure 5A & 5B: Expanded details of consented roof

2.4.1 Figure 5A provides an expanded section of the builder’s hand-drawn sketch submitted in the application for a building consent, and Figure 5B shows the addition of packing strips to provide the 25mm air gap requested by the authority.

- However, the subject roof has continuous plywood sarking supporting the roof underlay, which has significantly reduced natural air leakage.
 - The plywood sheet enclosing the cavity (see Figure 5A) does not accord with the intent of E3/AS1 1.1.4 b), which the specialist considers is:

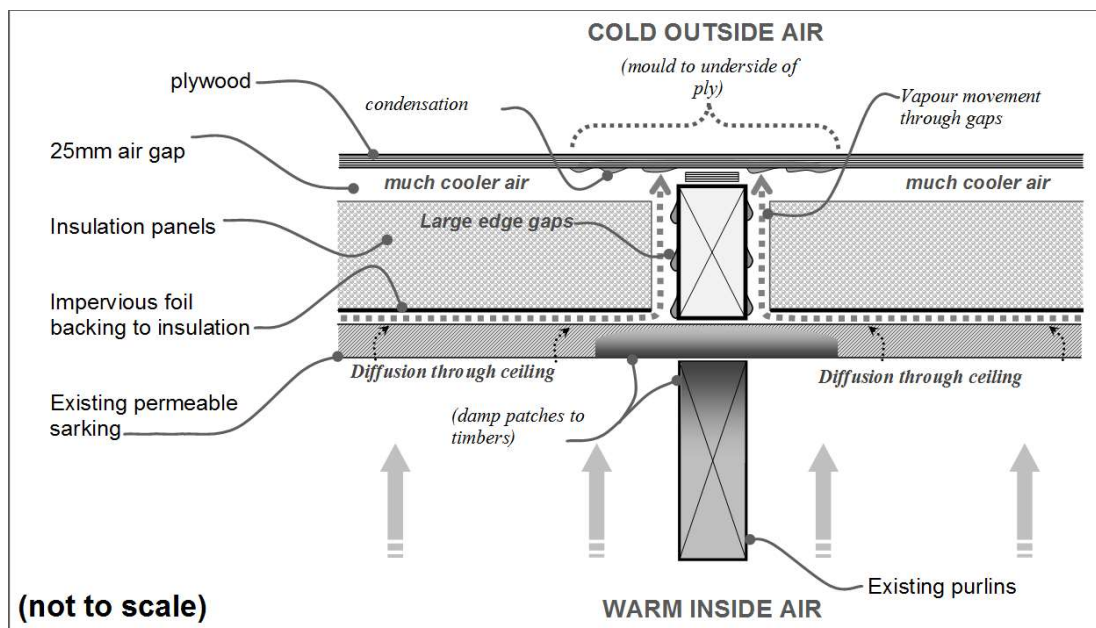
Figure 6: Moisture movement through the assembly

6.1.6 Moisture currently appears to be moving within and through the framing as shown in the following schematic sketch:

6.1.7 The above observations satisfy me that the skillion roof as-built does not comply with Building Code Clause E3. This is because the presence of the accumulated moisture over time would cause damage to building elements.
