Determination 2021/020

Regarding the refusal to issue a code compliance certificate for 23-year old additions and alterations to a residential dwelling at 36 Knights Road, Rothesay Bay, Auckland

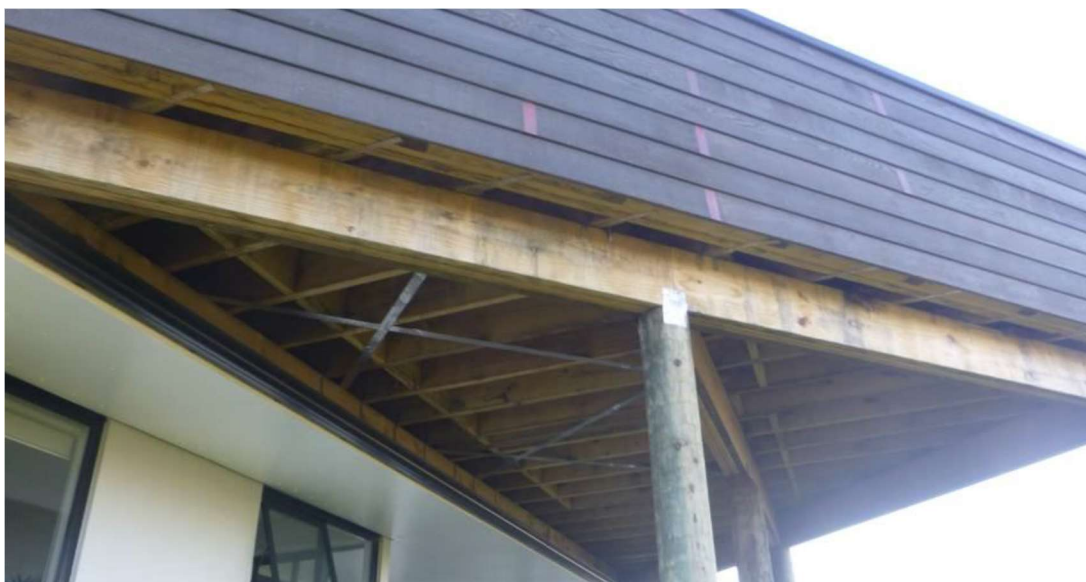
5.5 The expert noted that the bearer connections to the deck timber posts do not have the bolt fixings that are shown in the 1998 consent, and require checking as it appears that the connection has only been made using the nail plates (see photo 1). The expert considered this was a potential safety issue. This issue is not the matter for determination, but I do bring it to the attention and benefit of the parties for further consideration.

Photo 1: Deck post to bearer connection with nail plate

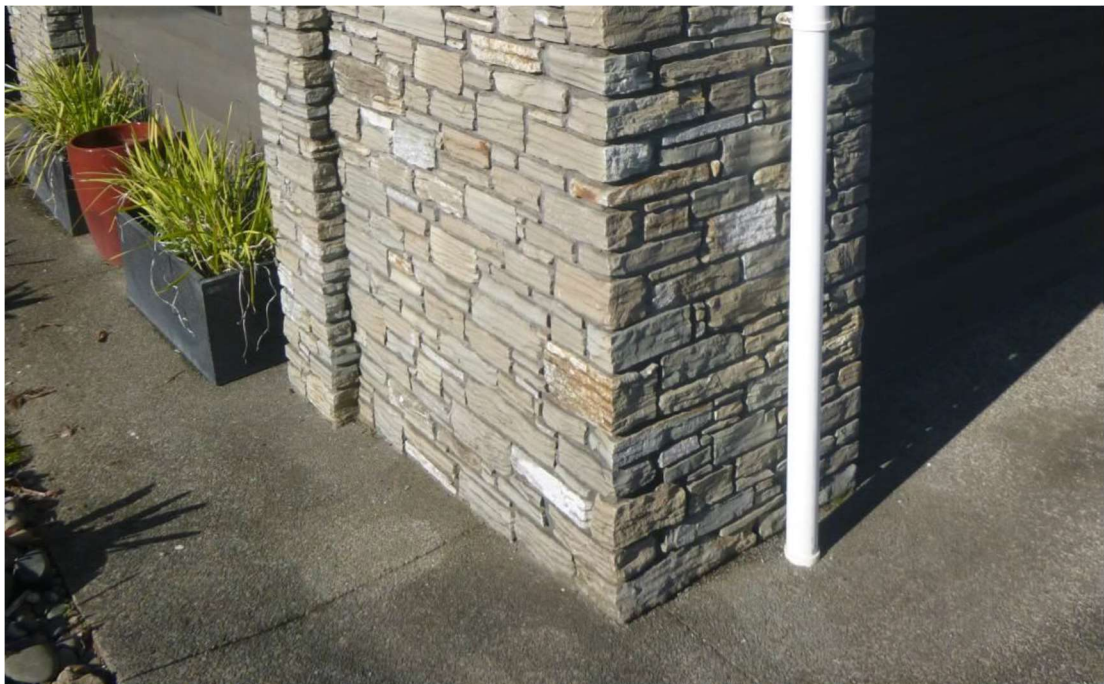
- 5.12 The expert noted the stone schist cladding was built up like a brick veneer cladding over a cavity with weep holes at the base and that it was, in parts, at or below driveway level as indicated in the photographs included in the expert's report. The expert also noted it was not clear whether a damp proof course had been installed and whether the foundation was stepped.
- 5.13 The expert also stated "the schist veneer stonework was found to be performing. Although some insufficient ground clearance exists near the garage door, and the driveway slopes toward the corner of the building" (see photo 2).

Photo 2: Ground floor, northwest corner – stone schist cladding

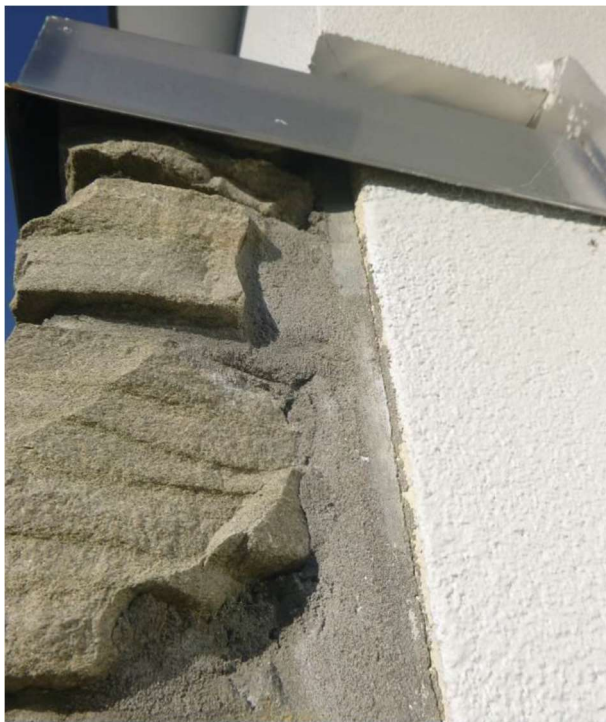
- 5.16 The expert checked the schist stone cladding, weatherboard and EIFS cladding junction on the north elevation of the building.
- 5.17 At the junction between the schist stone cladding and the EIFS cladding, at the northeast and northwest corners at first floor level, the expert observed a grout and plaster joint was formed, which appeared sound and with no obvious signs of moisture ingress. The expert could not confirm if a back-flashing was installed, but noted that the stainless steel flashing above provided adequate protection from the top (see photo 3).

Photo 3: Stone schist cladding to EIFS cladding junction, northwest corner

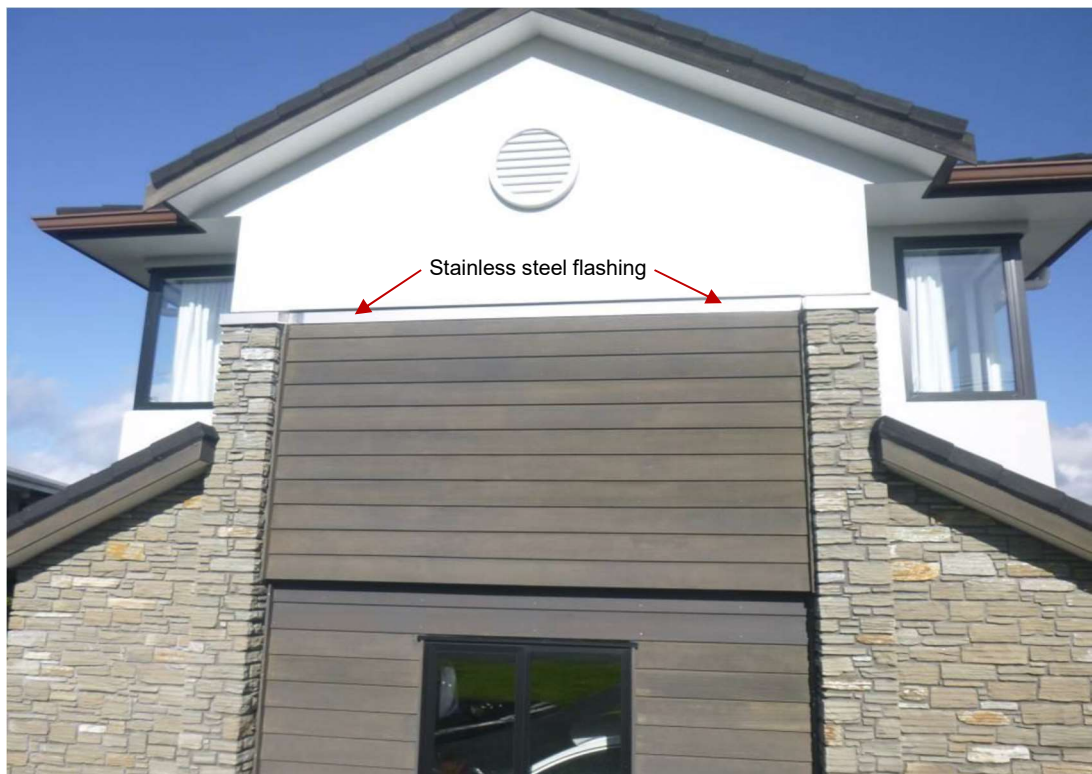
5.20 The stainless steel flashing referred to in the expert's report is located across the north elevation gable wall of the building, at the junction of the EIFS cladding, the stone schist cladding, and the horizontal weatherboards (see photo 4). The expert noted that the "flashing was formed and joined adequately and provided 20mm clearance to the EIFS cladding above". The expert also noted that "the flashing covered the top of the schist cladding column feature well but did not cover the tops of the [timber] scribes between [the] weatherboard and schist [cladding]...at either side". The report stated that "sealant has been applied unsuccessfully here and water can enter behind the scribe".

Photo 4: Stainless steel flashing, north elevation gable wall
