Determination 2023/031

Decision by an authority to grant a building consent and issue a code compliance certificate for a small dwelling

251 Priest Road, Eketāhuna

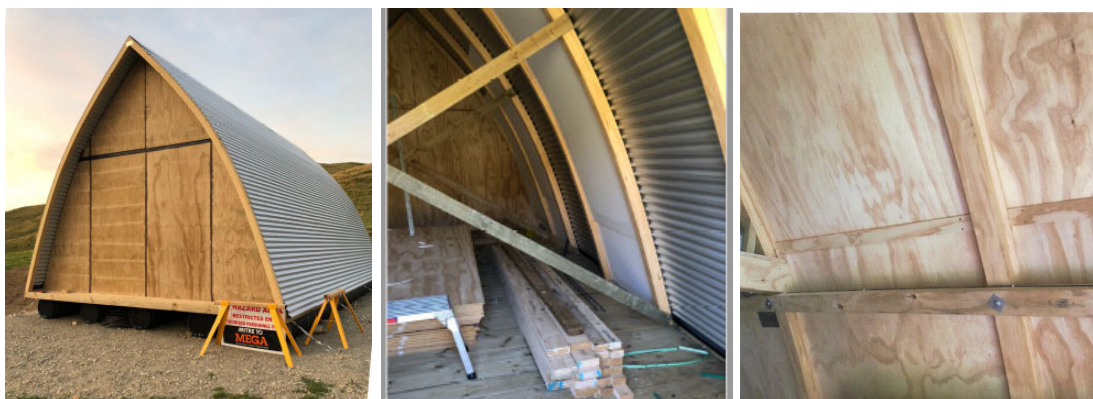
Figure 2: Photos showing construction of the roof, including the corrugated iron sheeting (left), curved frames and polystyrene insulation (middle) and internal plywood lining (right).

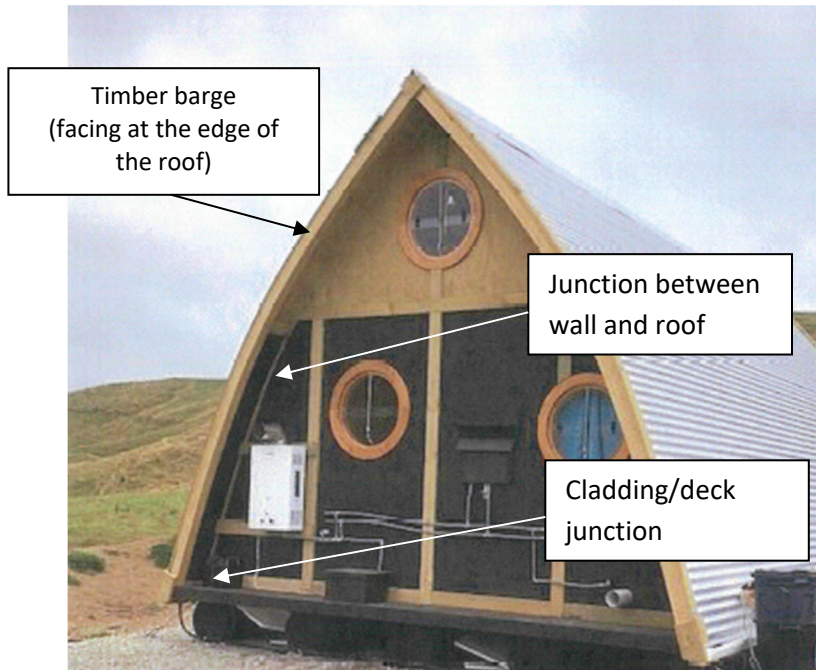
Figure 3: Rear view of the Ark.

<p><i>Junction between roof and deck (see figure 3)</i></p> <ul style="list-style-type: none"> • There is no detail in the plans shown for the junction between the roof and the deck. • It has been constructed with a timber bead, but I have no information about whether there is any flashing at this junction. • The timber bead will not be sufficient protection from moisture tracking inside the building elements at the junction between the roof/deck and at the point where this meets the wall. • The junction between the roof and deck as-built does not prevent moisture from being absorbed and transferred into the roof and wall system at that joint. Moisture will be absorbed and transferred into the building assembly and damage is likely to occur to the ply lining of the roof assembly along this junction and the untreated internal linings. This does not comply with clause E2.3.2.
Conclusion	<ul style="list-style-type: none"> • As-built, complies with the building consent but the design lacks sufficient detailing for weathertightness. • As-built, does not comply with clause E2.

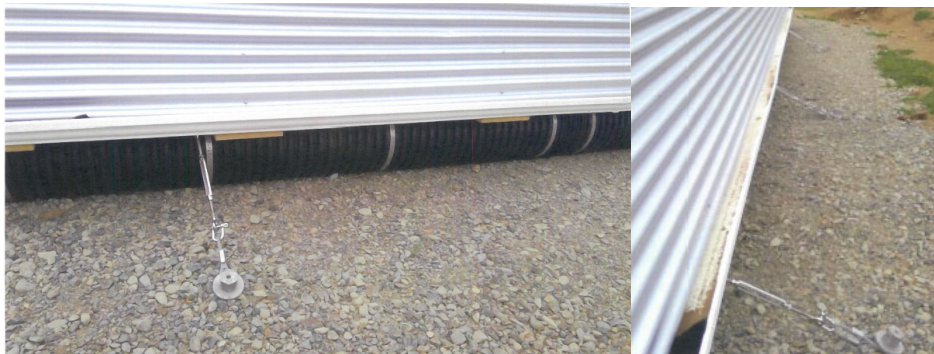
Figure 4: Photograph showing a pontoon and earth anchor (left) and earth anchors located on the side of the dwelling (right). Note the angle of rigging screws and anchors.

The anchor fixings are not installed at angles for the ground conditions.

Ministry’s assessment	<ul style="list-style-type: none"> • Section A shows 22mm stainless steel rigging screws installed vertically along the side/external wall, connecting the timber platform to the load-point (head) of the screwed earth anchor, which is inclined at 40-45degrees (see Figure 1). • The installation guide for the specified proprietary anchor required the anchors to be installed at the same angle (or close to) as the load for maximum pull out strength³³ when guying on an angle. • As-built, the earth anchors are guyed at an angle, meaning the rigging screws are not vertical as per the design. Also, the anchors

Building Code Clause	B1 – Structure B1.3.1 Buildings, building elements and site work shall have a low probability of rupturing, becoming unstable, losing equilibrium, or collapsing during construction or alteration and throughout their lives. B1.3.2 Buildings, building elements and site work shall have a low probability of causing loss of amenity through undue deformation, vibratory response, degradation, or other physical characteristics throughout their lives, or during construction or alteration when the building is in use. B1.3.3 Account shall be taken of all physical conditions likely to affect the stability of buildings, building elements and site work including: (h) wind
Building work item	(1) Installation of ground anchors
Authority’s assessment	<ul style="list-style-type: none"> • The plans note the angle of installation should be 40° to 45°. However, photos show anchors at various angles, which do not appear to meet the parameters specified on the plans. • The authority does not consider that the ground anchors, as-built, comply with B1. The issue could be rectified by removing the anchors and reinstating them at the correct angle.
