Determination 2023/042

The compliance of a wall made of ponga logs with clauses B1 and B2 of the Building Code

1/12 Rokino Road, Taupō

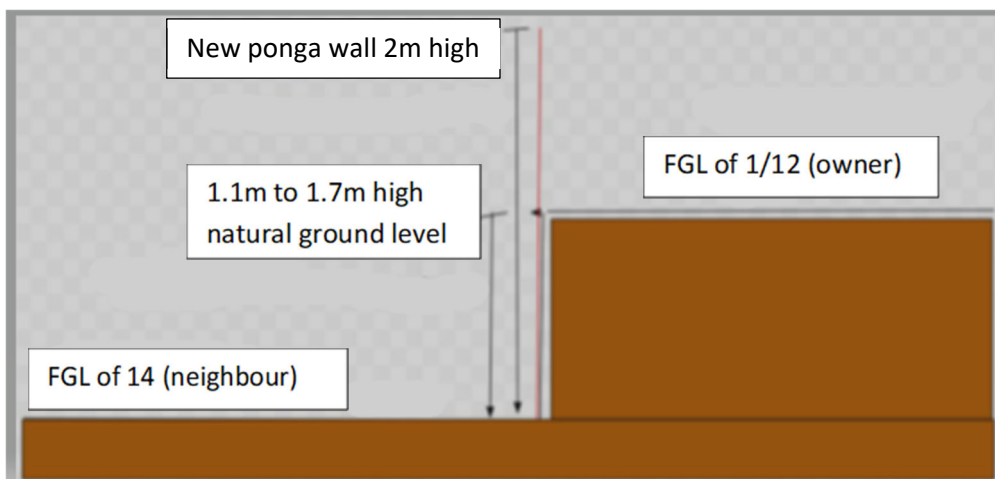
- 2.1. The owner's property is a back section in a residential area in Taupō and is accessed down a long driveway from Rokino Road. The section contains the owner's house, set toward the north-east of the property.
- 2.2. There is an existing retaining wall running the extent of the south-west boundary between the owner's and the neighbours' properties. This existing wall, including the section that is being replaced, is located on or near the boundary between the two properties (see Figure 1). The face of the wall is visible from the neighbours' property, with the wall retaining the ground level on the owner's property, which is higher in elevation than the neighbours' land (see Figure 2).

Figure 2: Diagram showing the relative finished ground level (FGL) of the properties (not to scale)⁶

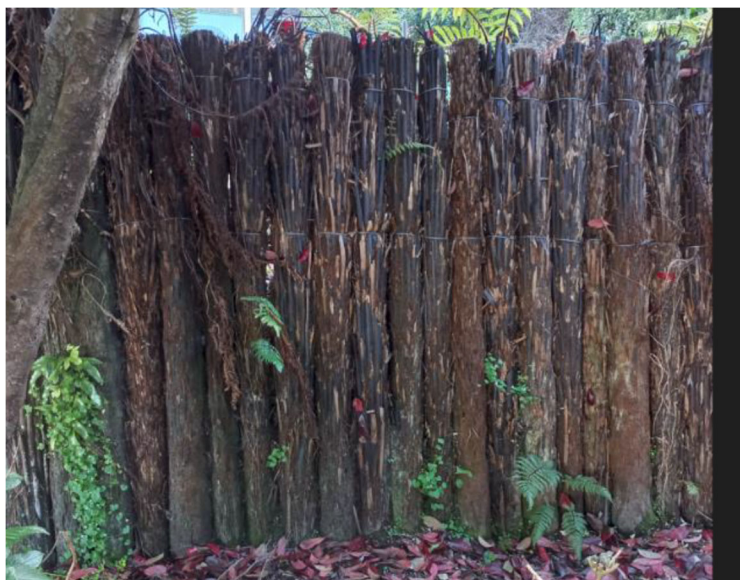
- 2.6. I have not received any plans or specifications detailing the design and construction of the ponga wall. However, from the photograph supplied by the authority it appears that the ponga logs have been sawn to a regular length, with flat tops and bottoms, and all side stalks, fronds and roots removed. The ponga logs appear to be thicker at the bottom than at the top, and are of varying diameters (see Figure 3).

Figure 3: Photograph of the new ponga wall (5.6m long and 2m high), from the neighbours' side, provided by the authority

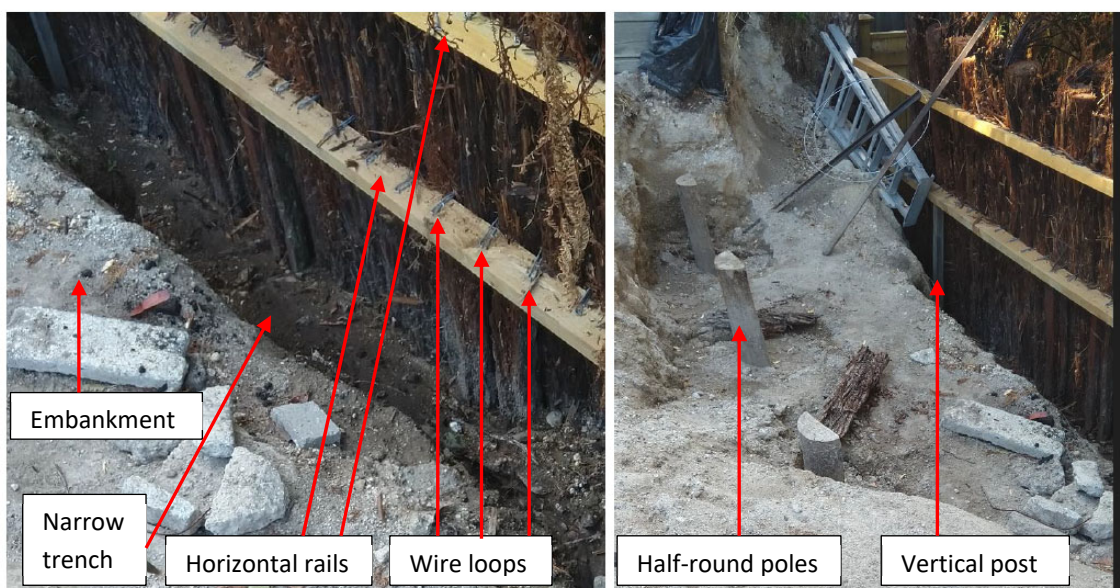
- 2.7. In terms of the installation, the ground adjacent to the new ponga wall has been excavated on the owner's side of the ponga wall. The excavation appears to have been in two steps; there is a narrow trench immediately alongside where the logs have been installed, which rises to an embankment. The excavation is not uniform,

and the narrow trench does not appear to continue the full length of the new wall. The embankment rises to approximately 1.1m above the ground-level of the neighbours' property (see Figure 4).

Figure 4: Photographs showing the excavation and punga wall from the owner's side

- 2.8. The punga logs have been fixed in place by two horizontal timber rails that run the full length of the new punga wall. One of these rails is near the top of the punga wall, and the other is about halfway down its height. The punga logs have been fixed to these rails using wire loops (see Figure 4). It appears that U-shaped fixings have been used to attach the wire loops to the horizontal rails. One vertical post supporting the lower rail is shown in the photos, but it is not clear if this is permanent or a temporary post. The bases of the punga logs have also been wired together in places.

- 2.9. No information has been provided by the parties to confirm if the punga wall is supported by any form of foundation. However, the photographs provided by the authority appear to indicate the bases of the punga logs are sitting directly on the ground (at ground-level of the neighbours' property) and have not been embedded into the ground to any depth. This has not been confirmed by either the owner or the authority, nor has it been contradicted in submissions. I also note that there are three half-round timber poles embedded in the embankment (see Figure 4). It appears that the owner may have intended to install tiebacks between the half-round poles (as anchors) and the punga log facing or horizontal rails, although I have not been provided any design information from the owner to confirm.
