## ***Waterproofing detail at base of brick veneer wall.***

- 1.1 The matter before the Authority is the adequacy of a waterproofing detail (“the detail”) constructed at the base of a brick veneer wall. The territorial authority concerned is withholding the code compliance certificate as it believes the detail to be inadequate.

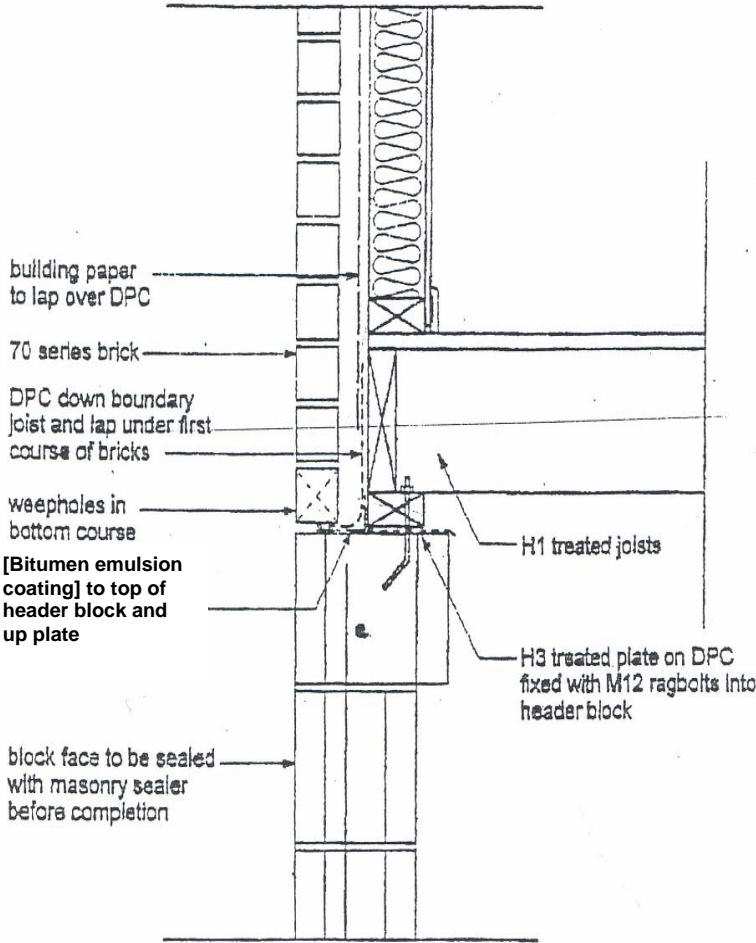
AS-BUILT FOUNDATION WALL DETAIL - SCALE 1:10

- 2.3 The detail provides for ‘waterproofing’ via a proprietary damp proof layer (“the DPC”) that runs “down [the] boundary joist and lap[s] under [the] first course of bricks” finishing approximately 30 mm back from the outside face of the wall. The building paper over the timber framed wall is shown as lapping over the DPC. Additionally, but only over those sections of the wall which abut the habitable unit, a bitumen emulsion coating has been applied “to [the] top of the header block and up [the face of the H3 treated] plate”. The brick veneer is shown as having weepholes in its bottom course and the H3 treated plate sits on a bituminous type damp-proof course.
- 2.4 The territorial authority had previously issued a building consent for the building based on drawings that included the detail.

The [DPC] has been lapped under the building wrap and fixed to the boundary joist, and folded out over the top of the [header] beam, finishing approximately 30-40 mm from the outer edge of the [header] beam.

- 4.4.5 The expert was not able to access the habitable unit but did inspect the subfloor space. The plate had a moisture content in the vicinity of 21% and there was moisture staining on the inside of the blockwork header following rain. The expert considered the fact that header was wetter on the inside than the lower part of the wall could be an indication of failure of the detail, however, he considered it could take many years for the consequences of failure to become apparent and be detected and would be very difficult to rectify.

There is no proposal to adhere the [DPC] to the top of the filled concrete blocks. Without a continuous waterproof connection between the underside of the [DPC] and the concrete blocks, water is able to flow under the [DPC] across the top of the blocks and into the interior. This water may be either from within the veneer cavity or even external water from house washing or rain that causes wetting to the lower portion of the bricks. Water will be drawn through this area by capillary action and this may either cause dampness to the adjacent bottom plate or to wall framing and lining materials of the lower habitable room.

There will also be an opportunity for water to travel between joints in the [DPC] because it will not be possible to provide a seal at the laps of the [DPC]. While the [DPC] may be provided in long runs it is inevitable that joints will occur and these will be vulnerable to water entry.

The causes of water entry will be capillary attraction under the [DPC] and water flowing through the unsealed joints in the [DPC]

- 5.3 The Authority considers that if the detail is to be accepted to achieve an equivalent performance, it is essential that the DPC is securely fixed to any substrate, and that the laps and angles formed in it are fully sealed and watertight. The Authority accepts the contentions of the expert that neither of these criteria has been met in this case.

- 6.1 In accordance with section 20 of the Building Act:
- (a) The Authority hereby determines that the detail without the provision for an upstand or nib does not comply with the relevant requirements of clauses E2 and B2 of the building code, whether installed over the habitable unit or over the sub floor areas.

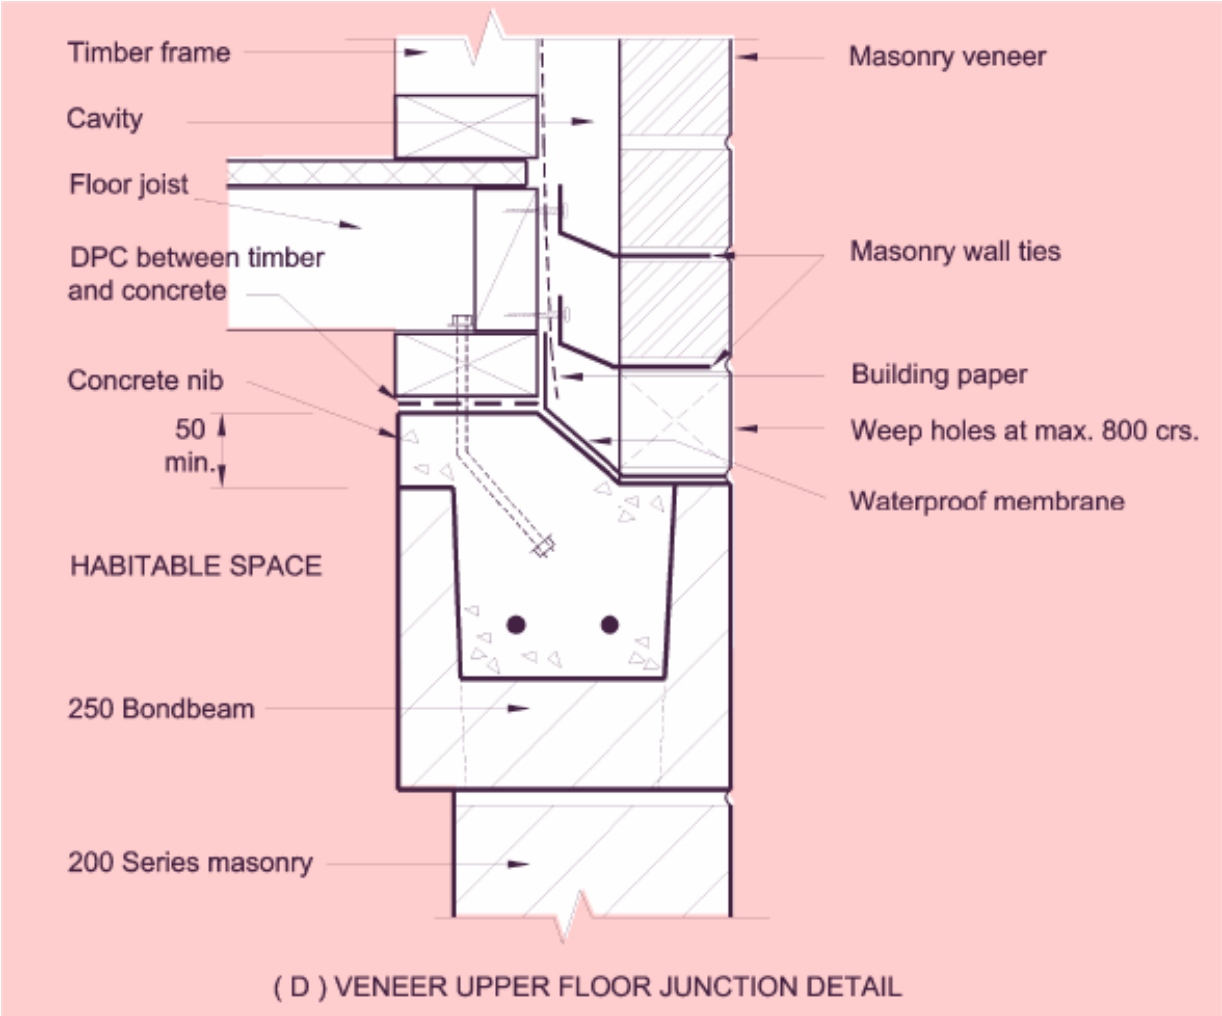
- 5.1 The Authority notes that Figure 3 in Acceptable Solution E2/AS1 shows a rebate and for the particular case where the detail is used next to a habitable space Figure 11.3(D) of NZS 3604:1999 has a 50 mm set down plus a “waterproof membrane”. The Authority considers there is no demonstrable conservatism in these details and that any proposal that eliminates the set down, needs to incorporate other compensating factors if it is to meet the requirements of the building code. To enable comparison with the detail Figure 11.3(D) of NZS 3604 is appended to this Determination as Appendix B.
