Determination 2006/91

Surface water requirements for a building at 311 Annandale Road, RD2, Henderson

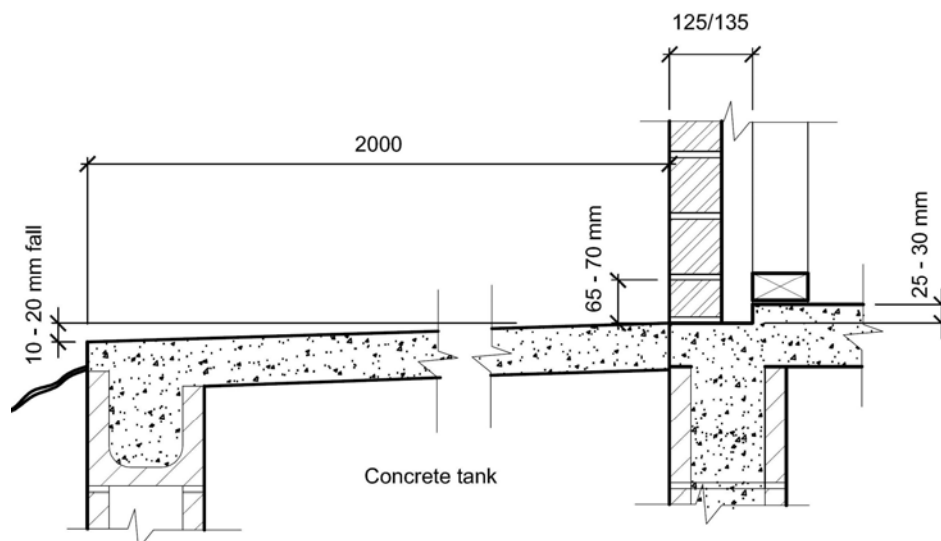
Figure 1: Wall adjacent the water tank

- (a) In the water tank area, the bottom course of the blockwork is set above the paving, resulting in an up-stand varying from approximately 25mm to 30mm high to the interior floor level: refer Figure 1.

- There is no gap between the bottom edge of the fibre-cement weatherboards and the concrete of the northeast garage porch.
- 5.5 The expert noted that, while the set-down of the veranda paving below the interior floor level is only 25-30mm at the water tank area, the paving to wall junction is sheltered under a 2.4m roof overhang.

6.4 I accept that the floor separation and clearance provided at the water tank area (Figure 1) is adequate in the circumstances, as the junction is sheltered beneath a 2.4m deep veranda roof and the concrete paving falls away from the house.

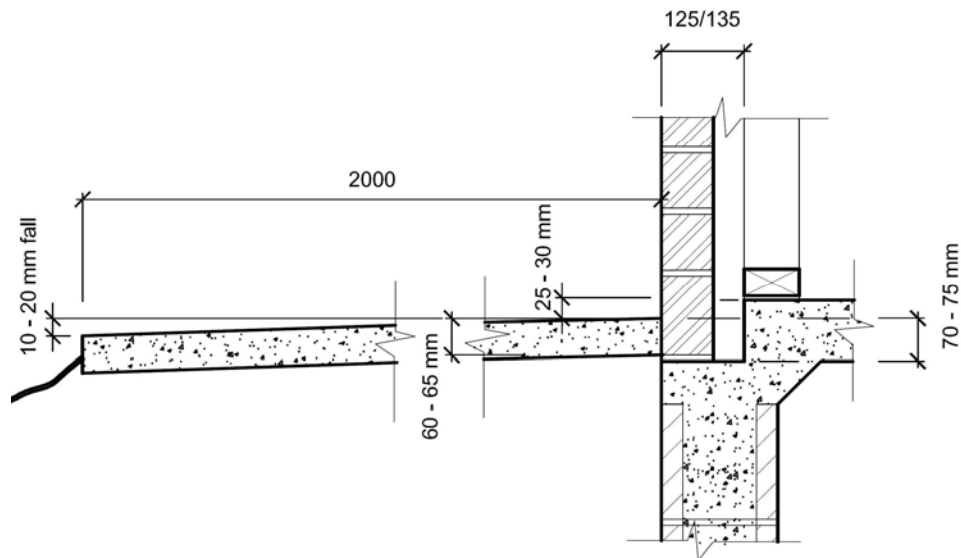
Figure 2: Wall generally adjacent the concrete veranda

- (b) Elsewhere the veranda paving has been installed after the erection of the block veneer, with the concrete paving poured against the block veneer resulting in the creation of a 70-75mm deep x 40mm wide channel between the block veneer and the rebate in the house floor slab at the bottom of the block veneer cavity: refer Figure 2.

- 5.4 The expert made the following specific comments on the cladding:
- Water is able to enter the blockwork cavity via the open perpend in the blockwork and will be trapped in the channel formed by the blockwork and the rebate to the floor slab (refer Figure 2).

6.5 The expert noted that the cavity at the base of the block veneer adjacent to the general veranda paving (Figure 2) can retain water entering from the exterior through the blockwork via the open perpends. The base of the wall cavity is below the top surface of the paving, creating an un-drained channel in the cavity 70mm to 75mm deep. Any water trapped in the channel may lead to elevated levels of moisture in the bottom plate and adjacent framing.

reaching the junction, however, there is very limited protection provided by the veranda in two locations (southern elevation at either end of the garage). Additionally, I consider that water is likely to enter the cavity as a result of normal maintenance and cleaning activities involving water, and in two areas where the lower wall may be exposed to rain, whether wind-driven or otherwise. Any water entering the cavity will be unable to drain away, which may lead to undue dampness within the cavity itself.

- 7.2 I consider that the drainage of the blockwork cavity is an essential element of what is intended to be a drained cavity system. At present this is compromised by the presence of what is effectively a non-draining channel between the blockwork and the rebate in the concrete floor slab. In particular, I am concerned that there is no apparent provision for any water entering the cavity to be able to freely drain away.

- 6.7 I also consider that, if a satisfactory method of draining the cavity is proposed, to the approval of the territorial authority, the clearances between the interior floor level and the veranda concrete will be adequate in these circumstances.

- 8.2 However, I am able to conclude that satisfactory rectification of the faults outlined in paragraph 5.4 will result in the building becoming code compliant.
- 8.3 I would suggest that the parties adopt the following process to meet the requirements of paragraph 8.2. Initially, the territorial authority should withdraw the notice to fix dated 12 May 2006 and issue a new notice to fix, requiring the owners to bring the house into compliance with the Building Code. The notice to fix may list the items to be rectified but it should not specify how compliance is to be achieved as this is for the owner to propose and for the territorial authority to accept or reject. It is important to note that the Building Code allows for more than one method of achieving compliance.
