## Determination 2007/66

### Determination regarding a code compliance certificate for a house with monolithic cladding at 61B Newhaven Terrace, Mairangi Bay, North Shore

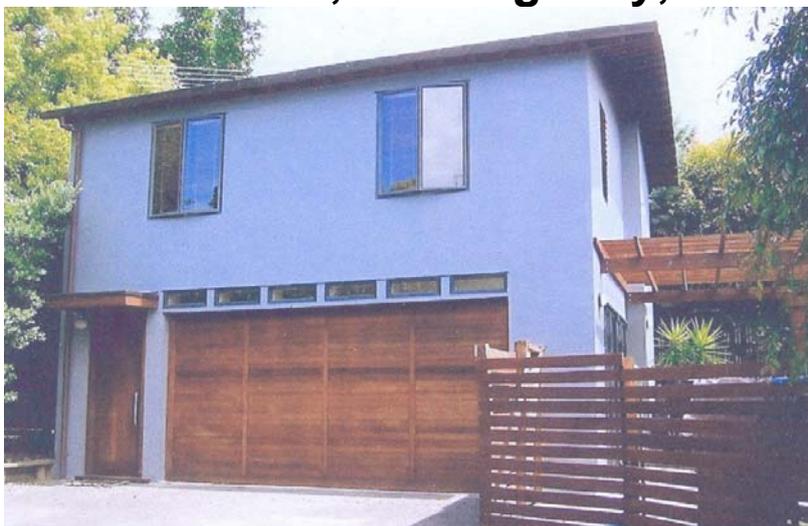
2.1 The building work consists of a small 2-storey detached house, situated on a gently sloping site, which is in a moderate wind zone for the purposes of NZS 3604<sup>3</sup>. The house is conventional light timber frame construction, with a concrete slab, foundations and low retaining walls to the west and south walls, monolithic cladding and aluminium windows. The house is simple in plan and form, with a single level roof over the upper floor and a lower level projection to the south elevation. Both low-pitched roofs are clad in curved profiled metal, with exposed rafters at soffits and eaves and verge projections that vary from about 300mm to more than 600mm. A small canopy, with a flat membrane roof, extends above the main entry door on the east elevation. A timber pergola is fixed to part of the north wall.

- 2.3 The expert noted no evidence as to timber treatment. Due to the age of the building the external timber framing is likely to be boron treated but I have received no evidence to confirm this.
- 2.4 The cladding system is what is described as monolithic cladding. In this instance it consists of 7.5mm thick fibre-cement sheets fixed directly through the building wrap to the framing, and finished with an applied textured coating system.
