Determination 2009/62

The issue of a notice to fix for a house at 92A Reihana Street, Orakei, Auckland

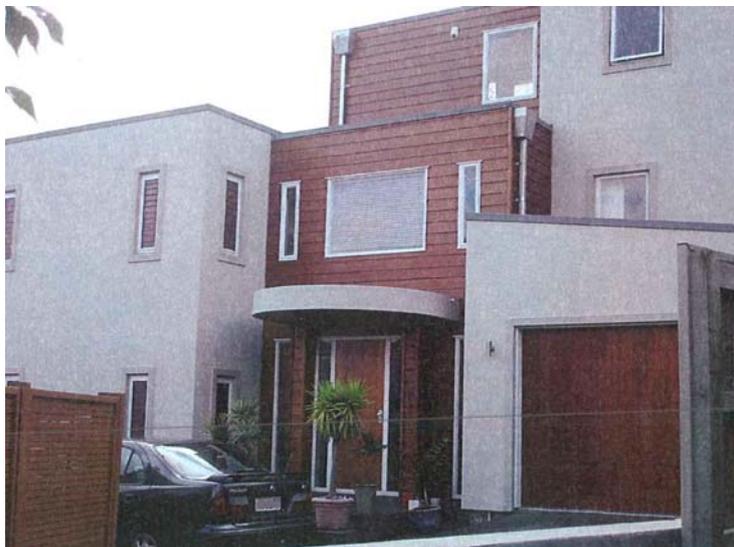
- 2.1 The building is a complex, three-storey dwelling, constructed on a steep site, in a high wind zone for the purposes of NZS 3604⁴. The construction consists of concrete blockwork and ground slabs, and light timber frame, which is clad in a combination of monolithic cladding and weatherboards, with aluminium joinery. There are two balconies, a curved porch, and flat and pitched roofs and parapets, all of which are clad with a butynol membrane. The balconies are tiled over the membrane. The roof has internal gutters and no eaves.

- 2.2 The exterior cladding combination is direct fixed cedar weatherboards and textured coated EIFS on 60mm polystyrene that has been installed over a cavity system.
