## Determination 2009/78

### Determination regarding the refusal to issue a code compliance certificate for a 5-year-old block of 5 semi-detached townhouses at 1 to 9 Duxfield Drive, Waitakere City

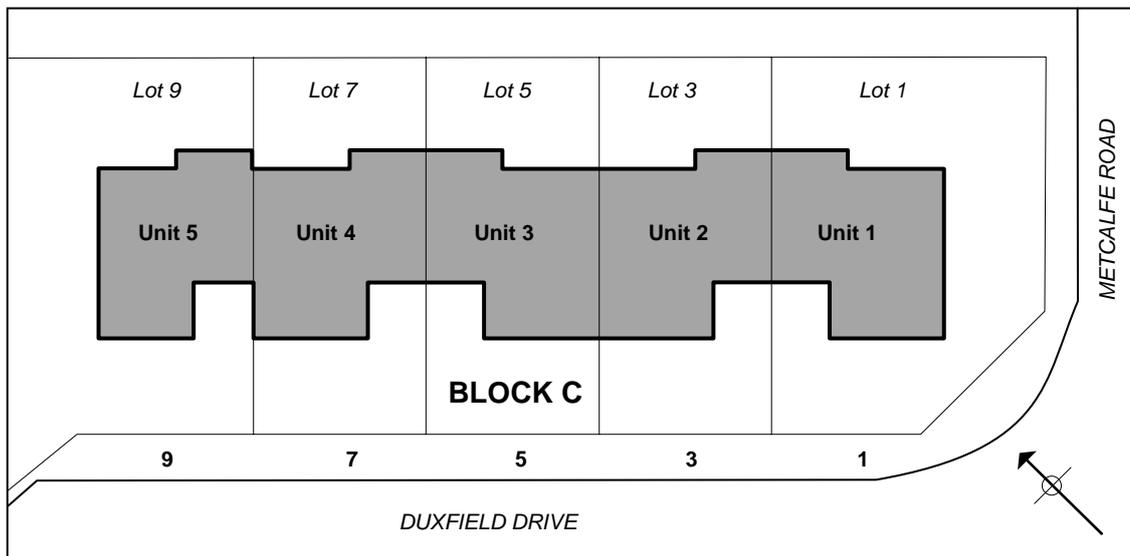
3.1 The following site plan shows Block C:
