Determination 2009/87

Determination regarding the code compliance of basement alterations to a house at 19 Fontenoy Street, Mt Albert, Auckland

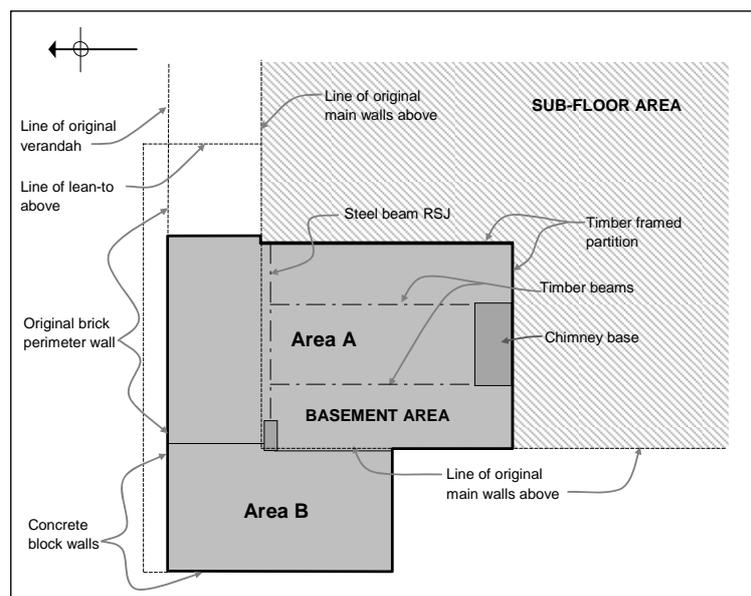
2.2 The following sketch shows the basement and sub-floor areas considered within this determination:
