## Determination 2009/103

### The compliance of a roof to part of a new house at 28D Rata Street, Oxford, Waimakariri

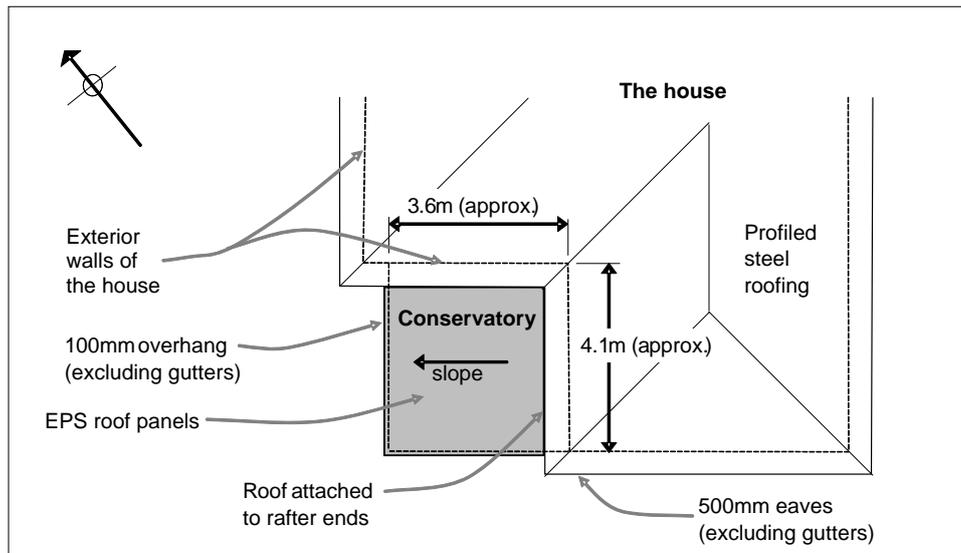
- 2.3.1 The conservatory was added under an amendment to the original building consent following the completion of the exterior of the house. The conservatory has conventional aluminium windows, with brick veneer and timber framing up to sill height, apart from ranchsliders to the northwest wall. The exterior brick walls to the main house are retained, along with ranchsliders from the living room.
- 2.3.2 The conservatory occupies the internal corner to the west of the house as shown below:

- 2.3.3 The conservatory roof that is the subject of this determination is a polystyrene sandwich panel system attached to the eaves of the main house, with the roof falling to the northwest. At the upper end, the roof is attached to a timber plate fixed to the ends of the house rafters while the side of the roof butts against the house eaves, with apron flashings at the junctions.

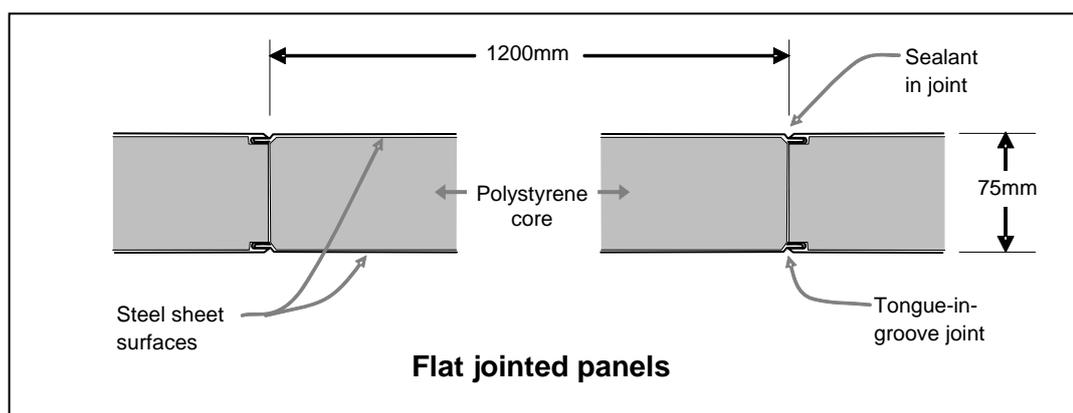
- 2.4.1 The roof is constructed using prefabricated panels, with the panel joints parallel to the fall of the roof. The consent drawings show the roof at a minimum pitch of  $1.5^\circ$ , with a gutter at the northwest end and the junction between the end of the roof and the gutter covered by a metal “Z” flashing.
- 2.4.2 The roof panels are 1200mm wide and 75mm thick; and incorporate a polystyrene core sandwiched between pre-finished flat steel sheets as shown below:

- 2.4.3 The edges of the steel outer faces are folded to incorporate a tongue-in-groove joint system. Sealant used on the exterior results in the joints sitting slightly proud of the roof surface.
- 2.4.4 I note that the consent drawings do not specify the particular roof panel system used; and from the manufacturer’s descriptions of its products it appears that the flat-jointed system is intended for use as wall cladding. The systems described by the

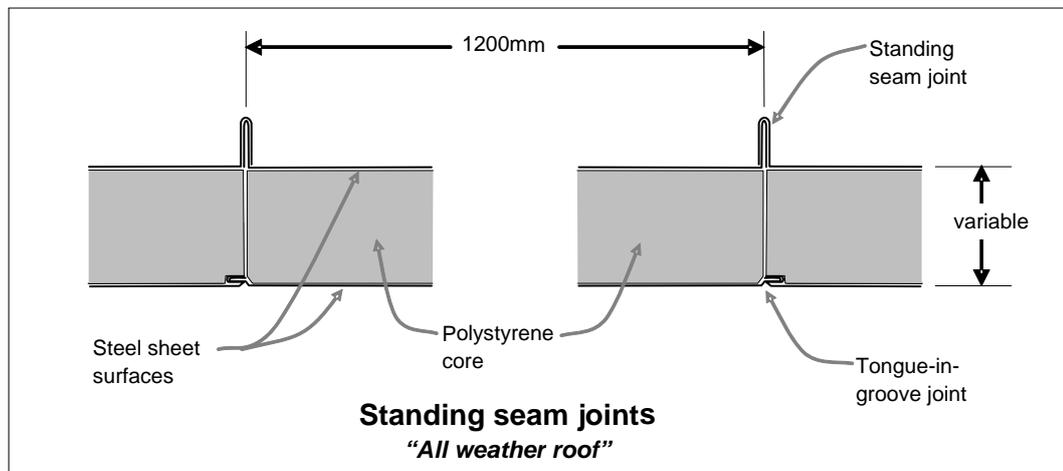
manufacturer as ‘roofing’ include the product described as an ‘all weather roof’ (shown below). The all weather roofing panel incorporates a vertical mechanical seal and the manufacturer recommends a minimum roof pitch of 4°.
