## Determination 2009/108

### Code compliance of plywood sheet and plywood weatherboard claddings on a house at 18 Shakespeare Road, Wanganui

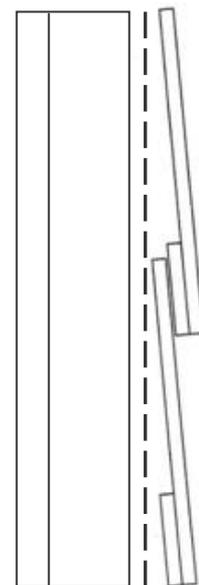
**Fig. 1.**

- 2.3 The weatherboards were made by cutting sheets of the plywood into 200mm strips to which 50mm strips (“ribs”) were glued, as shown in Fig. 1. The weatherboards are lapped 40mm or more and fixed through the laps to studs at not more than 500mm centres. Exposed bottom edges of the weatherboards were protected with a proprietary timber preservative coating. Butt joints were glued and covered with copper strips (“soakers”).

**Weatherboards fabricated from 7.5 mm plywood sheet.**
