Determination 2009/16

Determination regarding the code compliance of a 13-year-old monolithic-clad addition to a house at 56 Shelbourne Street, Nelson

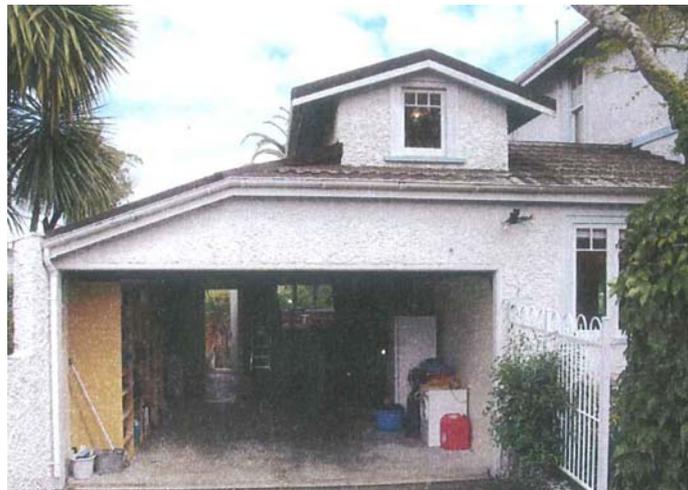
2.1 The building work consists of a garage addition of approximately 8.6 by 5 metres to a 90-year-old 2-storey house, which is situated on a flat site in a low wind zone for the purposes of NZS 3604³. The garage addition is single-storey, but includes a small mezzanine level with a narrow raised gabled roof area providing dormer windows for the upper level. Construction is generally conventional light timber frame with a concrete slab and foundations, monolithic cladding and timber windows with timber facings to match the windows of the existing house.

2.2 The addition is fairly simple in plan, but has a complex roof form. The pressed metal tile hipped and monopitched roofs to the lower level have no eaves or verge projections, while the raised gable roof has eaves projections of about 500mm overall and verge projections of 200mm. The original lean-to roof of the existing house has been altered to accommodate the new garage roof construction and includes an area of flat membrane roof, with additional valley gutters to either side.

2.3 The south wall of the addition is a fire-rated boundary wall that extends up to form a parapet with a metal capped top and an internal membrane-lined gutter behind. The wall extends beyond the east wall and then steps down to become a timber-framed boundary fence, which has monolithic cladding to each side and to the top.
