Determination 2009/38

Determination regarding the code compliance of a 12-year-old house with monolithic cladding at 516A Waimea Road, Nelson

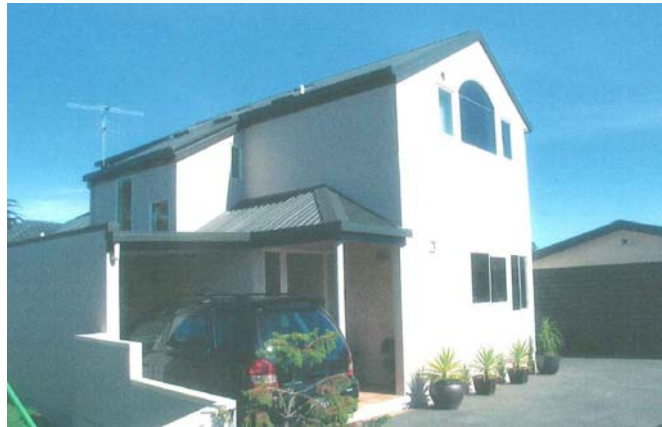
2.1 The building work consists of a large house, which is two-storeys in part and is situated on a flat site in a medium wind zone for the purposes of NZS 3604³. Construction is generally conventional light timber frame, and includes concrete slabs and foundations, monolithic cladding and aluminium windows.

2.2 The house is fairly complex in plan and form, with 30° pitch profiled metal hipped and gabled roofs. The lower level forms an “L” shape around a pool, with verandahs and doors facing the pool at western internal corner. The south-western end of the lower roof has eaves projections of 600mm, with 400mm projections around the west corner of the upper roof. Elsewhere, there are no eaves or verge projections.

2.3 The master bedroom extends beyond the upper roof with a flat membrane roof and parapets. The angled bay projection opens onto a tiled deck set within the body of the roof to the northwest “leg” of the “L” shape. The monolithic-clad inner walls of the inset form the deck barrier, with a capped upstand at the roof junction.
