Determination 2010/022

Refusal to issue code compliance certificates and the issue of three notices to fix for a 15-year-old house with subsequent additions at 5 Ewing Road, Laingholm, Waitakere

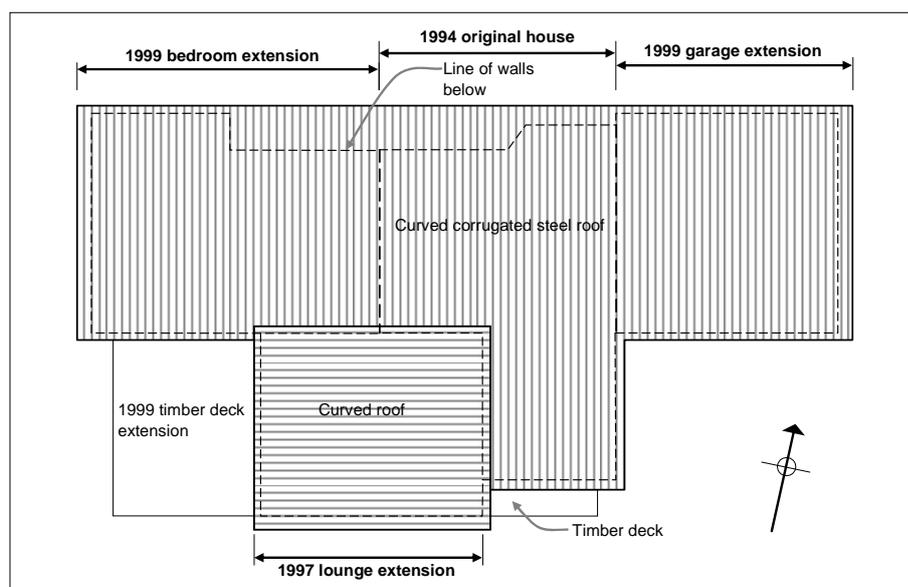
2.1 The building work consists of a single-storey detached house situated on a sloping coastal site in a high wind zone for the purposes of NZS 3604⁴. Construction is generally conventional light timber frame, with the original house and later extensions and alterations as indicated in the following figure:
