Determination 2010/053

The issue of a notice to fix for a house with a code compliance certificate at 24 Heretaunga Crescent, Cable Bay, Mangonui

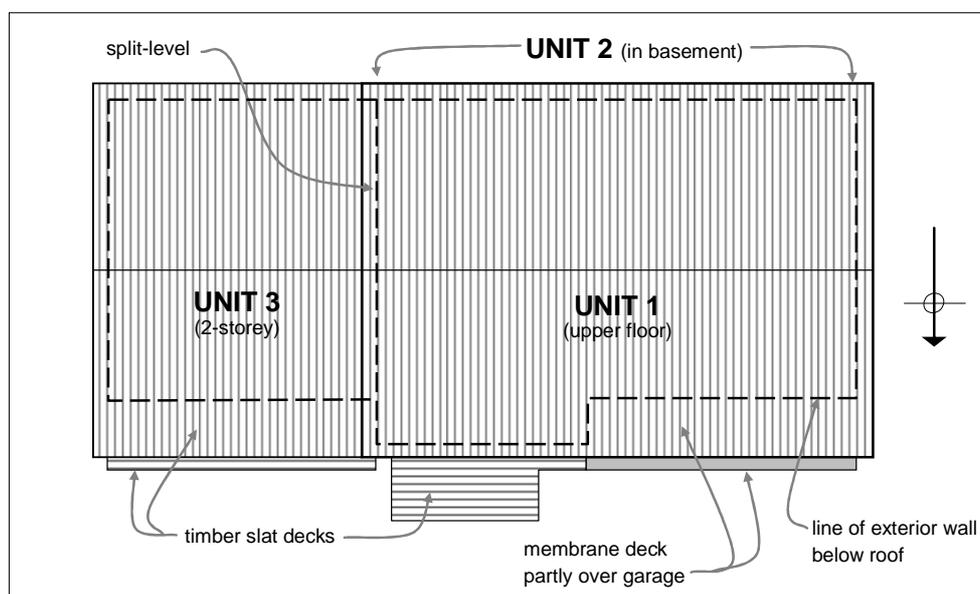
- 2.5 During construction, the house was subdivided (“the subdivision”) into three interconnected dwelling units as shown below:
