Determination 2010/75

Refusal to issue a code compliance certificate for a 12-year-old addition to house at 11 Duders Avenue, North Shore City

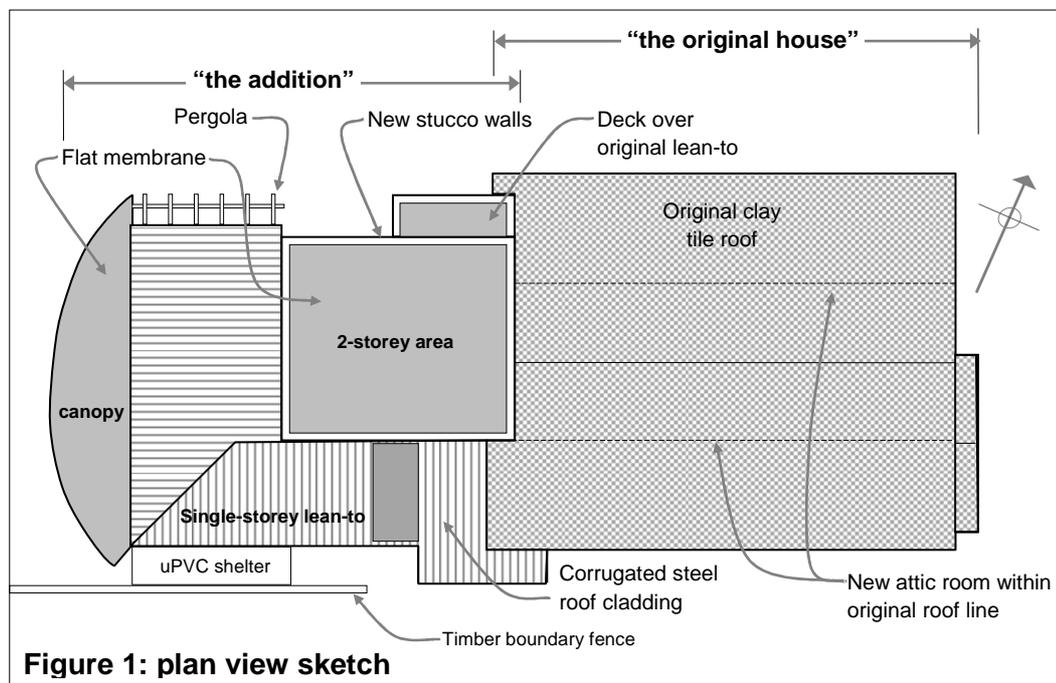
- 2.3 The addition is to the rear of the house as shown in Figure 1, and provides:
- a new kitchen, dining and family area on the ground floor
 - two small bedrooms and a bathroom in the upper level, with a developed attic area under the original roof and a new window to the east gable end wall
