Determination 2010/76

Refusal to issue code compliance certificates for an 11-year-old house and extension at 529 Horokiwi Road, Wellington

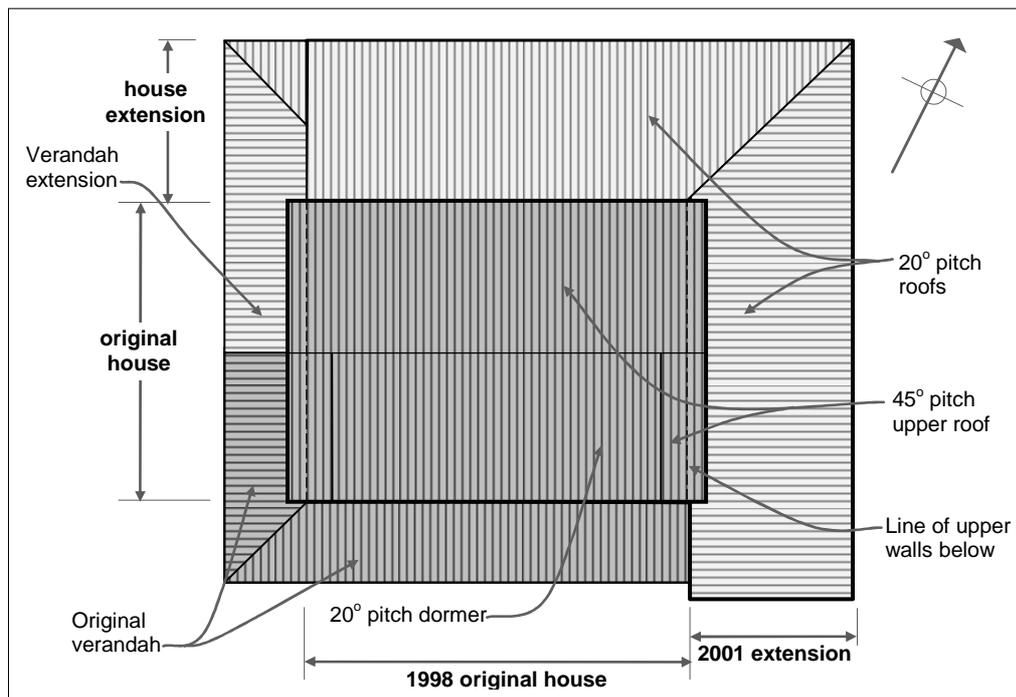
Figure 1: The original house plus extension

2.1 The building work consists of a detached house and separate garage building situated on an exposed site in a wind zone requiring specific design for the purposes of NZS 3604⁴. Construction is generally conventional light timber frame, with the original house and the extension as shown in Figure 1.
