## Determination 2010/83

### The compliance of proposed remedial work to window jambs on a house with monolithic cladding at 164 Quail Road, Kanohi, Rodney District

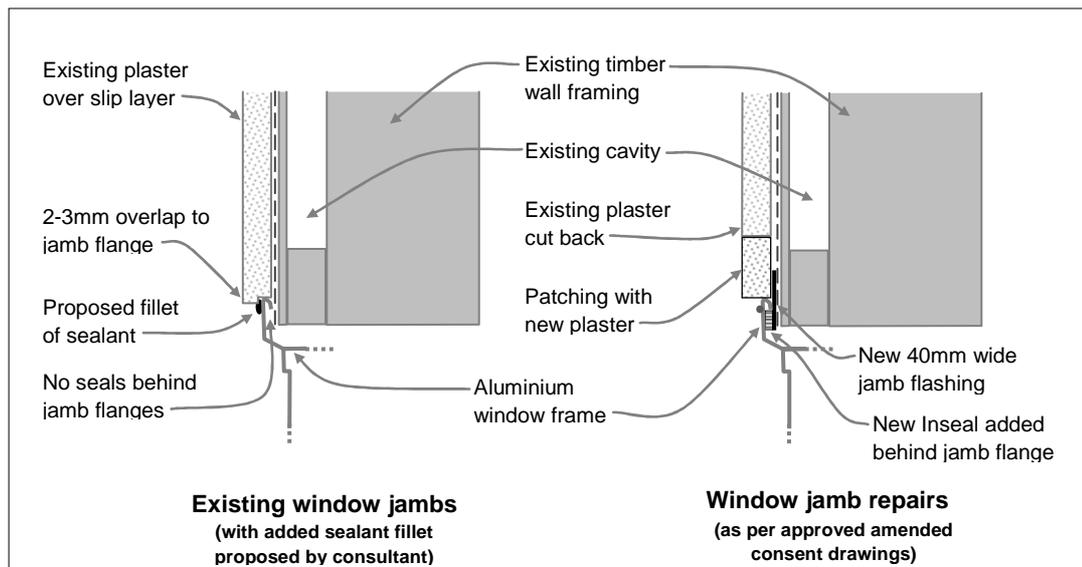
2.4.1 The aluminium windows are installed directly against the fibre-cement backing sheets, with the plaster applied up to and over the edge of the window jamb, overlapping the window flange by about 2 to 3mm.

2.4.2 The following simplified sketches compare the existing jamb detail (including the sealant bead proposed by the consultant) with the detail approved by the authority in the consent amendment drawings (see paragraph 3.6.1):

- 5.3.5 The expert was able to view the top and bottom of the installed jamb detail via the cut-outs, and noted that:
- window jamb flanges were installed against the backing sheets, with the plaster extending 2 to 3mm over the edge of the flange
  - probing behind the jamb flanges confirmed that no seals had been installed between the window flanges and the backing sheets.

- The jambs as installed incorporate no jamb seals and no jamb flashings.
  - The plaster provides little protection to the jamb junction, overlapping the window jamb flanges by only 2 to 3mm, rather than the 10mm indicated in the consultant's proposed detail.

- 3.6.1 The amended consent drawings included window details identical to the manufacturer's 2005 recommended details. The jamb detail included a 40mm wide jamb flashing over the backing sheet and foam sealant tape min 19mm thick x 10mm wide between the flashing and the jamb flange (see paragraph 2.4.2).

- 6.2.1 Taking account of the expert's report and the above observations, I am satisfied that the proposed sealant repairs to the window jambs will not provide adequate weathertightness and durability, as the edges of the plaster appear to be porous and those edges would still be exposed. However, while I consider that the consultant's proposal is inadequate, I am also of the opinion that the extent of additional work required is mitigated to some extent by the generally adequate past performance of most of the conventional windows.

- 6.2.3 I therefore suggest that an adequate level of durable weathertightness of the window jamb junctions may be provided by the addition of appropriate mechanical protection. Should the windows not be removed, then a solution involving an engineered sealant joint protected from sun and rain by an external cover flashing system would be required.
