Determination 2010/106

Refusal of a code compliance certificate for house alterations completed under the supervision of a building certifier at 27A Parkvale Road, Karori, Wellington

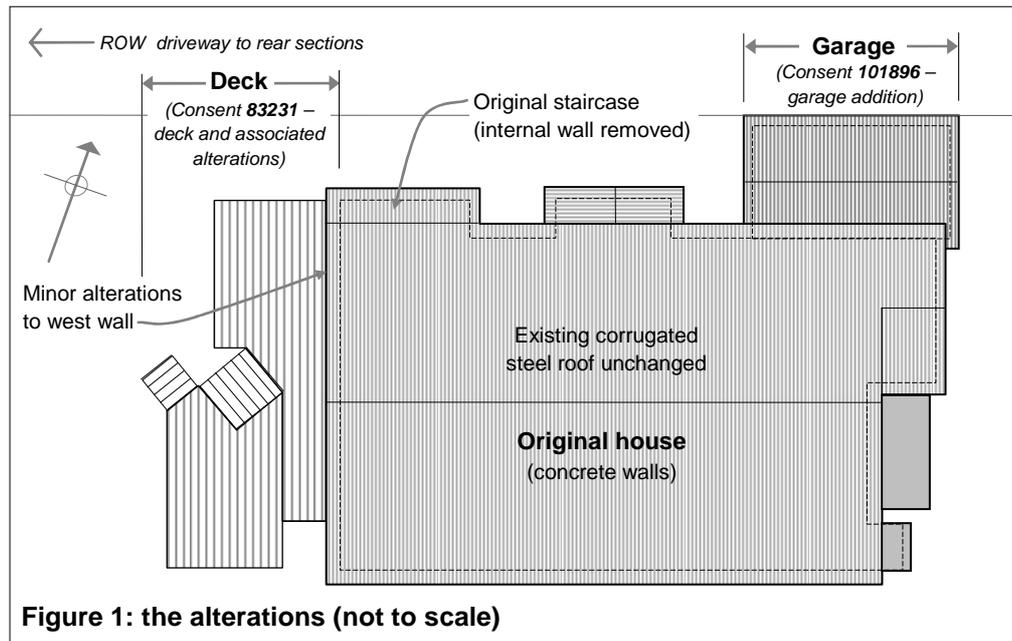
2.2 The alterations considered in this determination are shown in Figure 1:
