Determination 2010/112

Refusal to issue code compliance certificates for 13-year-old alterations to a building at 28 Hobson Street, Thorndon, Wellington

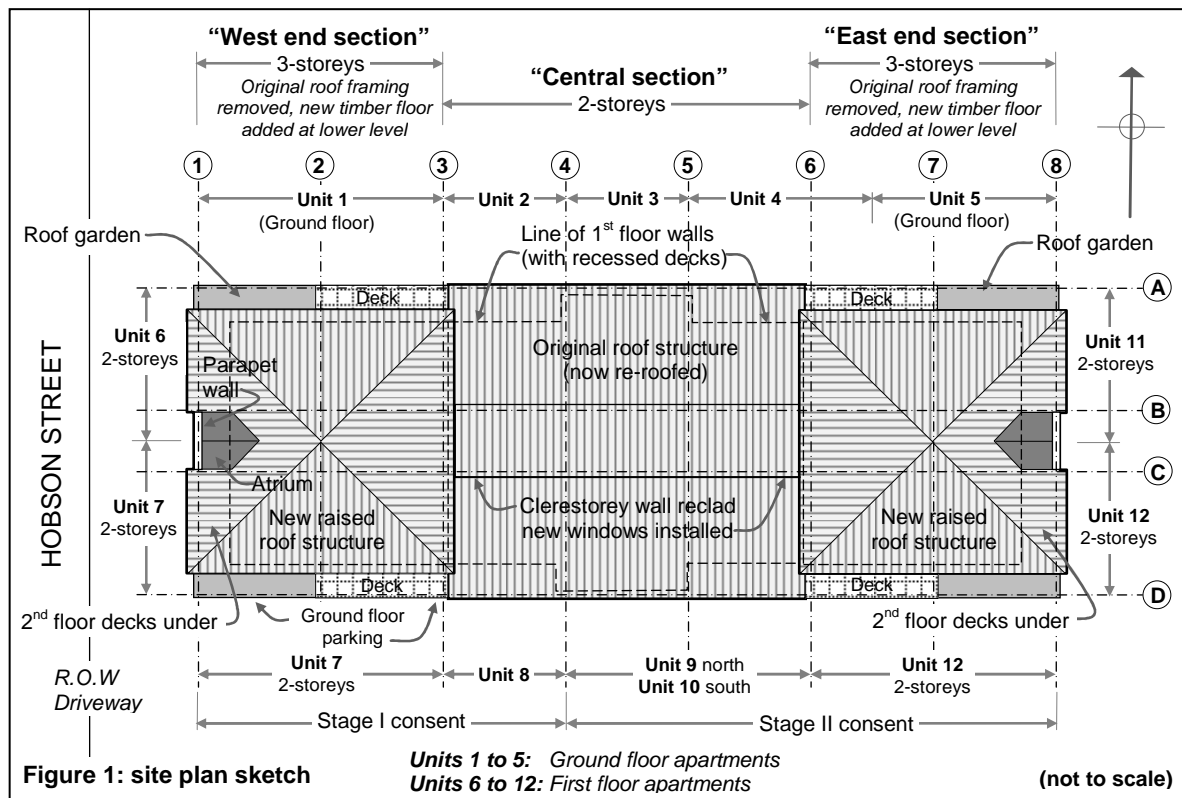
2.3.3 As shown in Figure 1, the building is made up of three sections, with east and west sections 3-storeys high and the central section 2-storeys high. The new construction added to the original concrete structure is generally conventional light timber frame, with monolithic cladding and aluminium windows. The altered building is fairly complex and is assessed as having a high weathertightness risk (refer paragraph 6.2).
