Determination 2010/126

The refusal to issue a code compliance certificate for a deck to a house at 29 Glenalmond Road, Mount Eden, Auckland

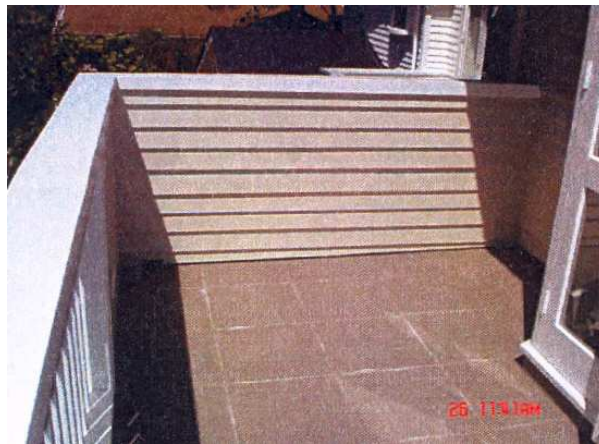
- 2.2.1 The 18m² deck is constructed as part of the garage extension below. The deck area contains two bay windows and has a tiled floor over a membrane on a 20mm compressed fibre-cement substrate. There is weatherboard-clad balustrade to three sides of the deck. The existing wall boards were not cut when the balustrade was attached to the house wall therefore no saddle flashings were installed.
- 2.2.2 The deck does not have a drain along the outer edge as consented, but relies on the slope of the deck to direct water away from the house and to the outlets. To achieve this, the deck floor falls from the house to the balustrade and from the centre of the balustrade outwards to two drainage outlets which are piped through the walls to discharge into the surfacewater system. The deck also has an overflow outlet at one end.
