## Determination 2011/011

### Refusal to issue a code compliance certificate for three 9-year-old buildings with monolithic cladding at 609 Halkett Road, West Melton, Christchurch

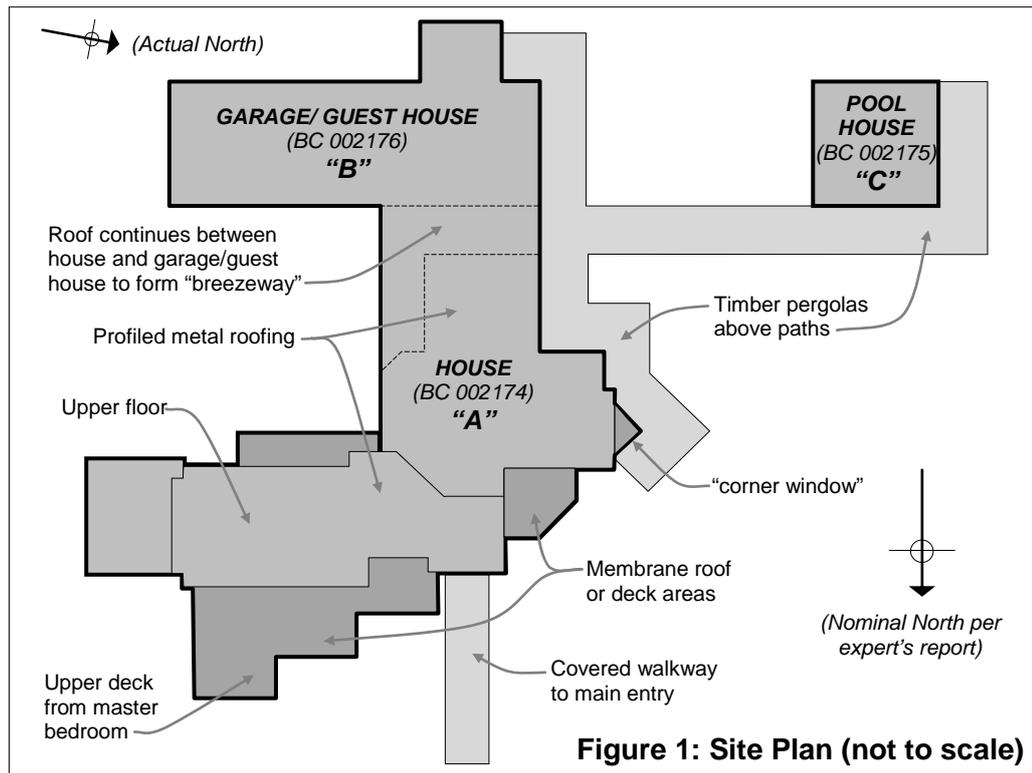
2.3 As shown in Figure 1, the house (“A”) and the garage/guest house (“B”) are linked together by the roof, which forms a breezeway between the two buildings. Buildings A and B are then linked to the poolhouse (“C”) with paths and timber pergolas. Attached pergolas continue along the west walls of the three buildings.
