## Determination 2011/018

### Determination regarding the compliance of window heads to a building at 955-957 High Street, Avalon, Hutt City

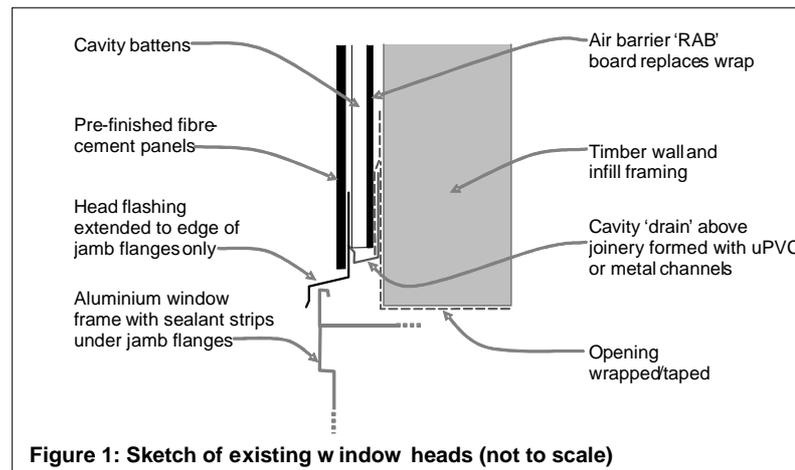
- 2.5.1 The commercial aluminium joinery comprises 158mm frame double-glazed units supported on WANZ<sup>5</sup> metal support bars. Joinery units are face-fixed against panels, with metal head flashings and compressible foam seals beneath the jamb flanges.
- 2.5.2 The cavity above joinery heads is drained via metal and uPVC channels, which extend beyond the window frames. However, the ends of the head flashings finish in line with the edges of jamb flanges, with no projections beyond the joinery frames. A typical window head is shown in the following simplified sketch:

- 3.2 However, although the WANZ recommended details call for the head flashings to extend 30mm past the joinery frames, the windows were installed with the ends of the head flashings finished in line with the edge of the jamb flanges.

- junctions at jambs and sills appear weathertight
- head flashings finish in line with the jamb flanges, with no turn-ups at ends
- gaps were apparent at the ends of the head flashings
- sealant had been applied to the ends of some head flashings, although most head flashings were unsealed
- the most exposed window was on the first floor northeast wall of Bedroom 1, below the parapet (I note this was the same window that the contractor proposed to expose)
- other windows which were more sheltered under overhangs are unlikely to be regularly exposed to wind blown rain at vulnerable head to jamb junctions
- the perforated cavity closure at the bottom of the cladding allows satisfactory drainage and drying of the cavity.

- Destructive investigation and dye testing of the most exposed window confirms that the head to jamb junction has been allowing water to penetrate in the past and is still able to leak at the end of the head flashing.
- Sealant repairs to the ends of the head flashing are not effective in preventing moisture from entering the cavity in the medium to long term.
- There is no evidence of moisture penetration past the cavity into the cavity battens, RAB and wall framing.
- The cavity is currently managing any moisture that penetrates at the head to jamb junctions.

6.4 It is my view that drained cavities are intended to manage any occasional moisture ingress resulting from the failure of the primary defence mechanism. A cavity is not intended to allow for regular, or expected, water ingress. In the case of the window investigated by the expert, it is apparent that the ends of the head flashing will allow moisture to penetrate on a regular basis.

8.1 In accordance with section 188 of the Building Act 2004, I hereby determine that the window heads as installed to the exposed windows to this building (see paragraph 6.5) do not comply with Clause E2 and Clause B2 of the Building Code.
