Determination 2011/028

Regarding a notice to fix for a partly completed house at 362 Hillsborough Road, Hillsborough, Auckland

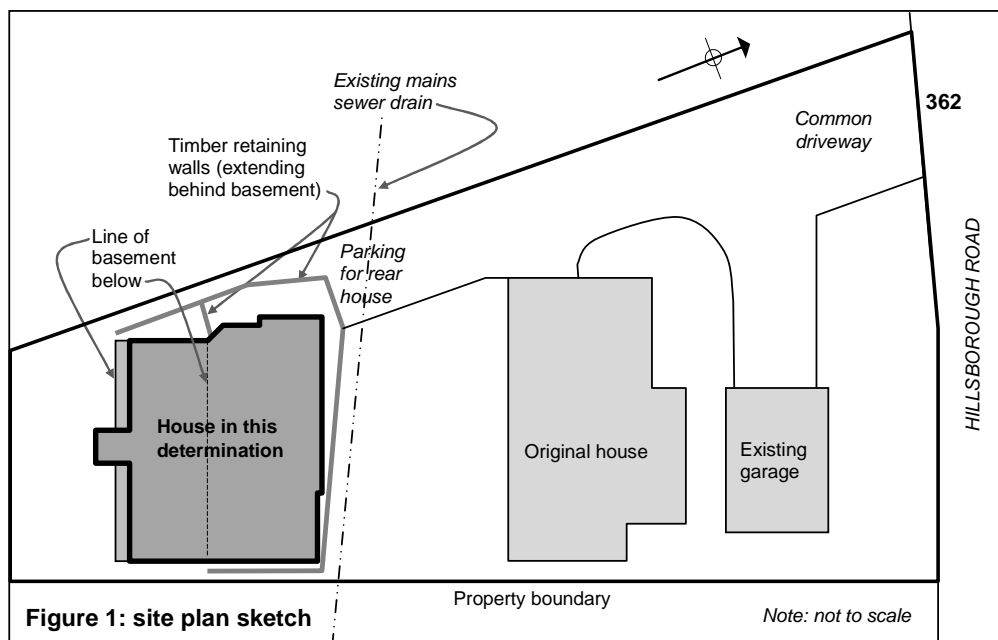
2.1.1 The subject house is to the rear of a large undivided section, with an older 1940's house and garage situated to the north. A shared driveway from the street provides access to the older house and extends to provide car parking for the rear house as shown in Figure 1, with timber steps leading down to lower level paving.

2.1.2 The un-subdivided south-sloping section narrows towards the rear where it is 'benched' with timber retaining walls to provide two building platforms. One of these walls extends through the subfloor of the house, while the other borders the west, north and east sides of the building platform. An existing mains sewer drain crosses the section; and is shown on the site plan as 1 metre north of the upper retaining wall.
