## Determination 2011/063

### Regarding a notice to fix issued for 8-year-old additions and alterations to a house at 15 Lingarth Street, Remuera, Auckland

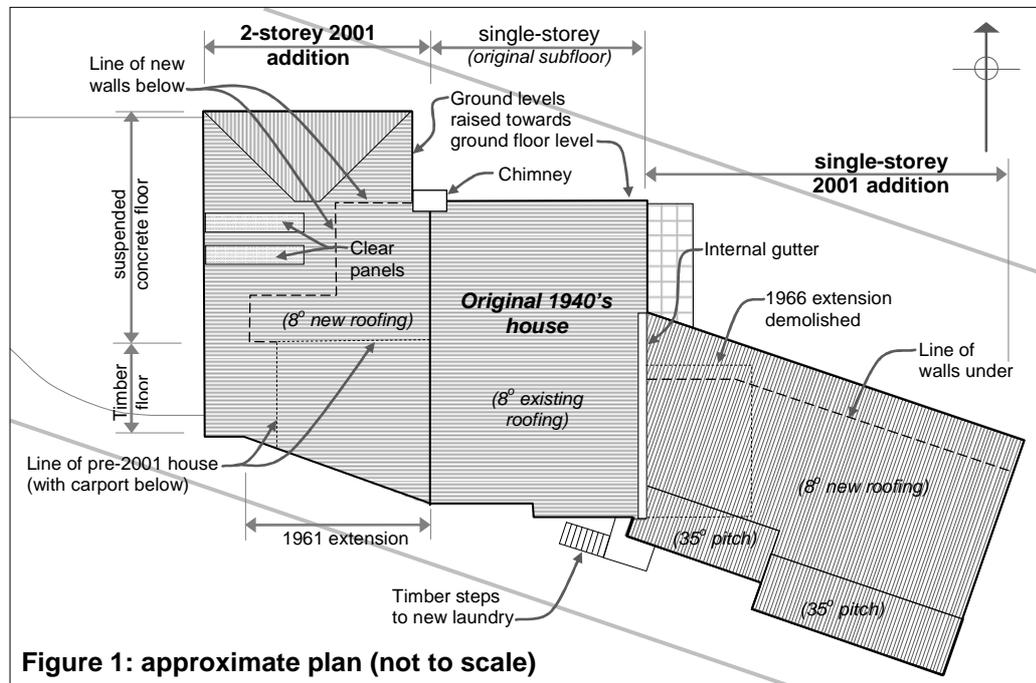
2.3.1 The subject alterations included significant additions to the west and east of the house as shown in the site plan sketch in Figure 1:
