Determination 2011/081

Regarding the refusal to issue a certificate of acceptance for repairs to a tiled deck on a house at 58 Columbia Crescent, Beachlands, Auckland

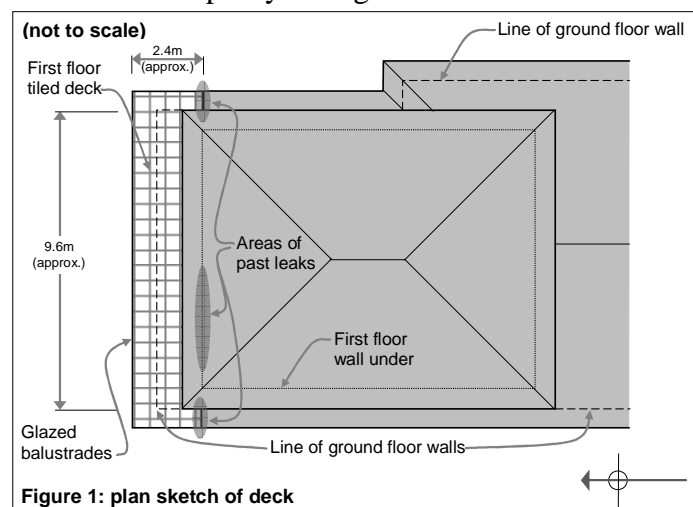
2.3 The 23m² deck is situated partly over ground floor rooms as shown in Figure 1:
