Determination 2011/096

The refusal to grant an amendment to a building consent for proposed remedial work, and the issuing of a notice to fix for a 13-year-old house with monolithic cladding at 54 John Rymer Place, Kohimarama, Auckland

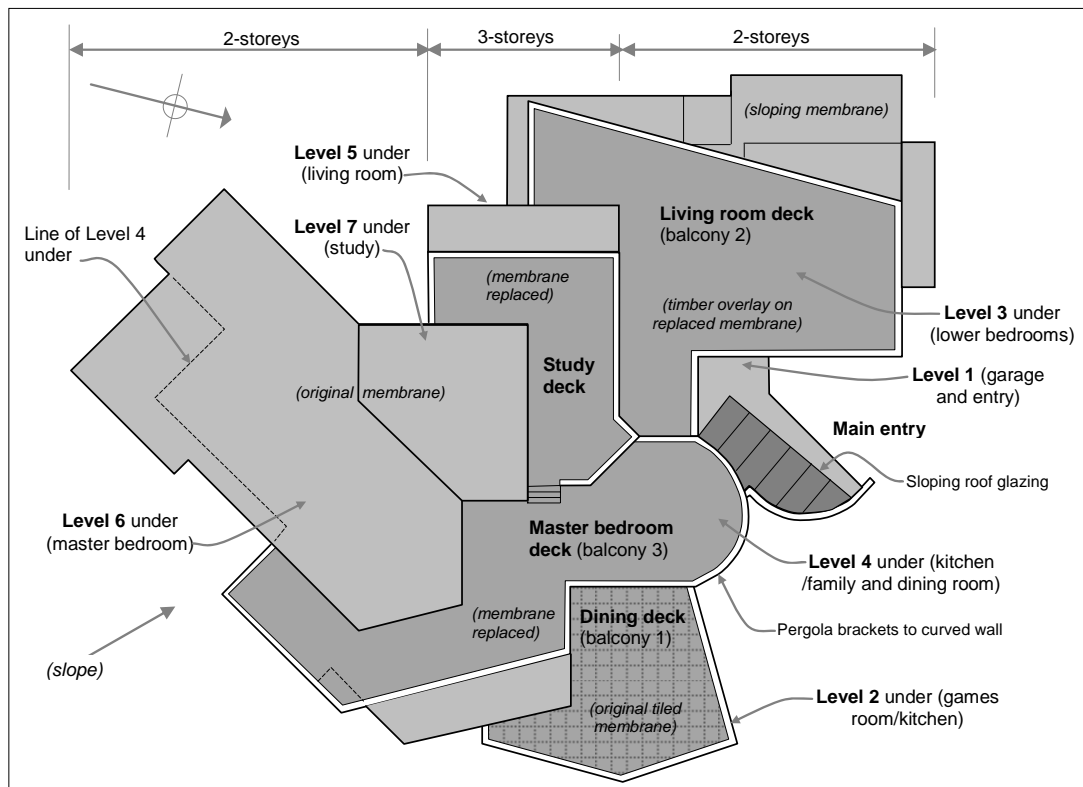
Figure 1: Layout of the existing house

- 2.1.3 The north and south ends of the house are two-storeys-high, with the central section 3-storeys high. The house steps up the slope, with decks provided at the upper four levels and walls set at varying angles as shown in Figure 1.
