Determination 2012/012

The issue of a notice to fix for a 6-year-old garage addition to a house at 28 Hackett Street, Auckland

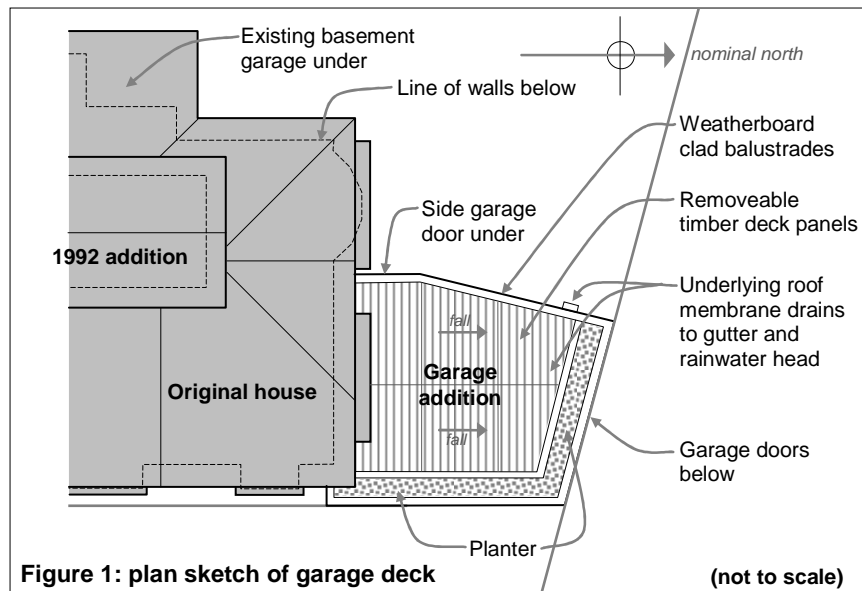
2.4.1 The building work considered in this determination is limited to the garage addition shown in Figure 1. The garage is at the northeast boundary of the site, and provides a roof deck accessible via new bi-fold doors from the adjacent living room. Construction is generally conventional timber frame, with a concrete slab and foundations and some specifically engineered steel portals and beams.

- 2.4.2 The walls are clad in horizontal bevel-backed timber weatherboards to match the walls of the original house, with the boards fixed through the building wrap directly to the framing. Timber facings border windows and doors, with scribes at the jambs and flashings over the head facings. Garage walls extend to form deck balustrades.
- 2.4.3 The drawings call for wall, roof, planter and balustrade framing to be H3 and the applicant has provided invoices from the timber supplier that describe the timber as 'H3.1 KD PG'. Given this and the date of construction in 2004, I consider that the framing is likely to be treated to a level that will provide adequate resistance to fungal decay.
