## Determination 2012/018

### The code-compliance of a deck added to a house at 30A Hertford Street, Blockhouse Bay, Auckland

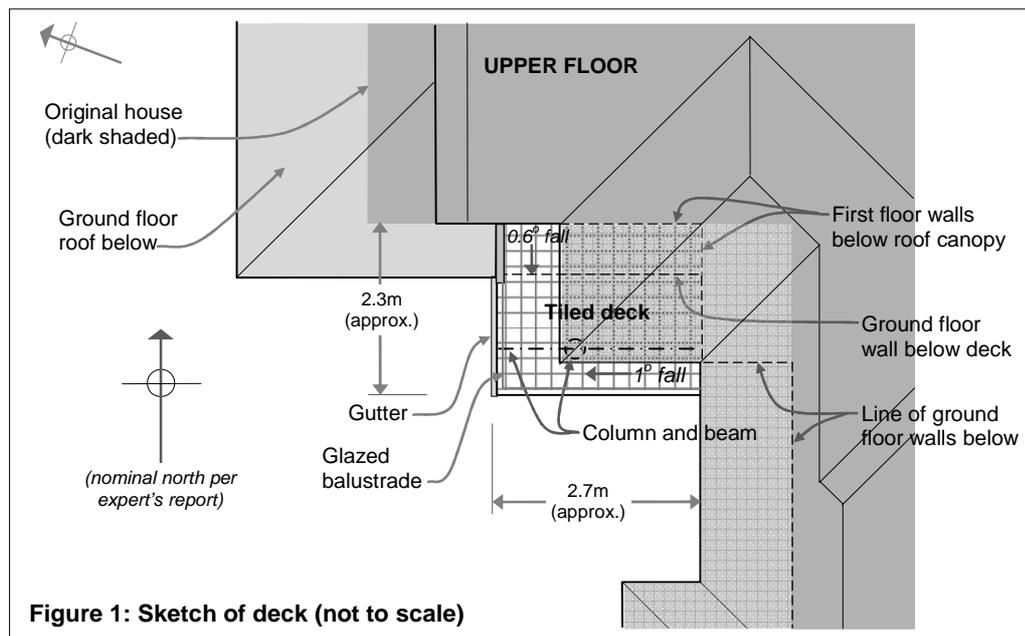
2.5.1 The deck considered in this determination is to the southwest internal corner of the altered upper floor, above the new main entry as shown in Figure 1:

2.5.2 A strip of about 700mm of the 6m<sup>2</sup> deck sits above the ground floor living area. The remaining deck floor is supported by a column and boxed beam, with a small cantilever along the south. The column extends to support a roof projection, which covers about half of the deck area. Glazed balustrade posts are side-fixed to the south edge, with a west post side-fixed to a part-height clad wing wall.
