## Determination 2012/055

### Regarding the refusal to issue a code compliance certificate for an 11-year-old house with monolithic cladding at 61B Oceanbeach Road, Mount Maunganui, Tauranga

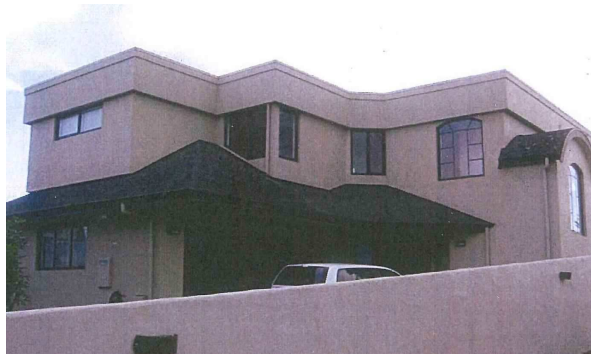
2.1 The building work consists of a two-storey detached house situated on an excavated building platform in an exposed coastal site in a high wind zone for the purposes of NZS 3604<sup>6</sup>. The original long narrow site slopes down towards the beachfront and was subdivided to provide three individual lots, with this house occupying the mid-section. The expert has taken the garage doors as south-facing, and this determination follows that convention. The house is fairly complex in plan and form and is assessed as having a high weathertightness risk.

2.2 Construction is generally conventional light timber frame, with concrete foundations and floor slab, monolithic wall cladding and aluminium windows. Flat membrane roofing is bordered with parapet bands that project 200mm. At the lower level, 30° pitched asphalt shingle lean-to roofs overhang most walls by more than 600mm.
