Determination 2012/065

Regarding the refusal to grant an amendment to a building consent for a house with timber window and door joinery at 13 Grey Crescent, Torbay, Auckland

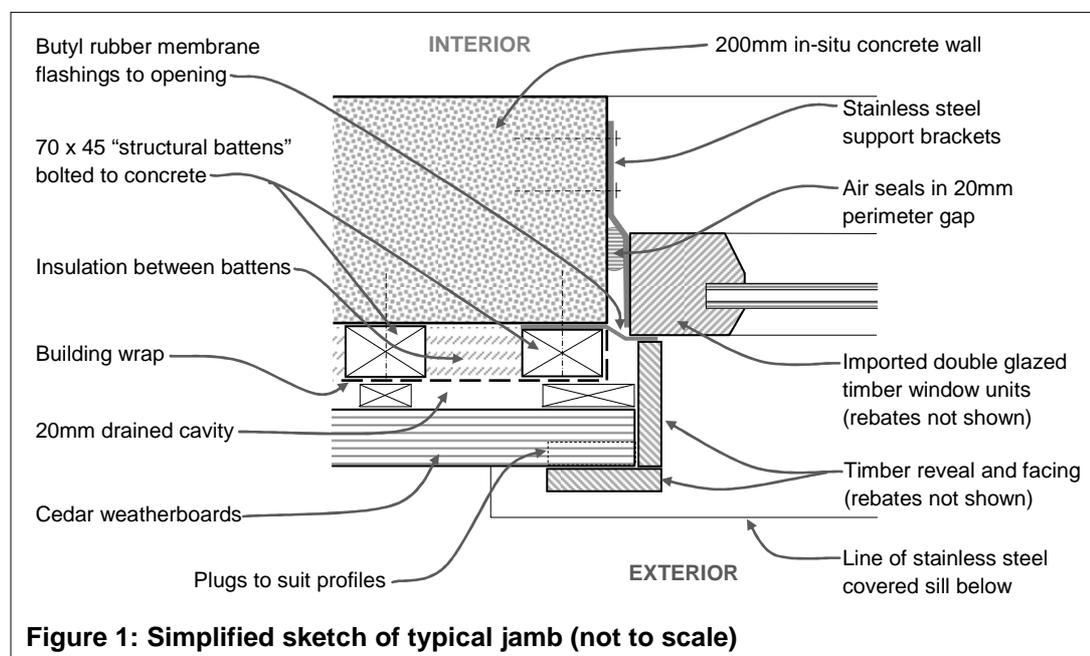
- 2.4.1 The original consent drawings called for aluminium joinery and the proposal is to substitute imported timber windows and doors; to be fitted within concrete wall openings as shown in the simplified sketch in Figure 1.

- 2.4.2 As shown in Figure 1, joinery units are supported by stainless steel brackets, with airseals fitted into a continuous 20mm perimeter gap and butyl rubber membrane covering the outer face of the gap. Building wrap is installed over battens and insulation, with weatherboards fixed over a drained cavity to the structural battens.
- 2.4.3 A projecting timber 'drip-head profile' is fixed to structural battens at window heads; with stainless steel head flashings above. Stainless steel also wraps over timber window sills, with rebated timber facings, scribes and reveals at jambs and head.
