Determination 2013/009

Regarding the refusal to issue a code compliance certificate for a 15-year-old house at 4 Swordfish Avenue, Whiritoa, Whangamata

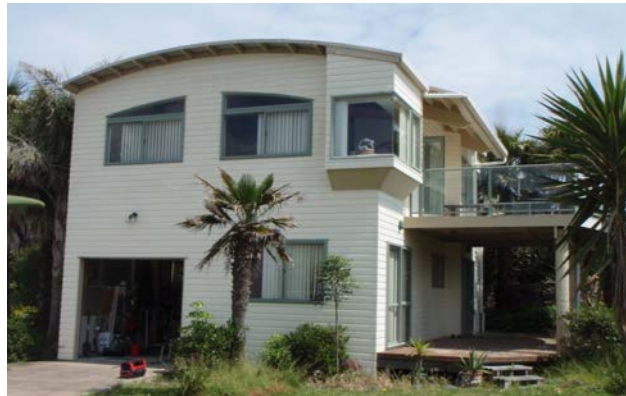
- 2.1 The building work in question consists of a two-storey house and attached garage situated on a gently sloping beachfront site in high wind and exposure zones for the purposes of NZS 3604⁴. The house is assessed as having a moderate weathertightness risk.

- 2.2 The house and garage are of timber-frame construction, with the house built on piled foundations and the garage built over a concrete slab. The curved roof is supported by portal frames and curved glulam⁵ roof members, is covered with profiled metal roofing, and generally has good eaves and verge projections to three elevations. There are no eaves to the south elevation or over the northeast boxed window, and the roof purlins and the undersides of the metal roofing sheets are exposed on the east and west elevations.

- 2.3 The exterior walls are lined with PVC weatherboard cladding directly fixed to the framing, and the exterior joinery is comprised of powder coated aluminium units. One window located at the northwest corner is boxed out and some windows have circular head profiles.

- 2.4 A large timber framed balcony is constructed over a non-habitable space at the upper floor level adjoining the north elevation and is supported by timber beams and poles. The deck of the balcony is covered with ceramic tiles fixed over a liquid applied membrane and ply substrate. A glazed metal framed balustrade is top fixed through the tiled decking at the perimeter of the balcony. Two other timber-framed decks are situated at the lower north and west elevations; both with open timber decking.
