Determination 2013/017

Regarding the refusal to issue a code compliance certificate for a 13-year-old house constructed under the supervision of a building certifier at 22A Phillip Street, Johnsonville, Wellington

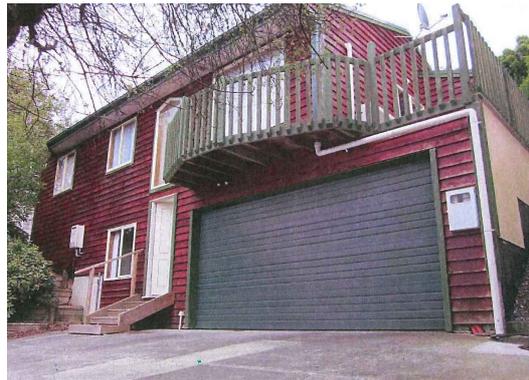
- 2.1 The building work in question consists of a two-storey house with an inclusive garage situated on a sloped site benched into a hill below a steep hill face. The site is in a medium wind zone for the purposes of NZS 3604⁴ and the expert has noted that the house is generally protected from north-westerly and southerly winds.

- 2.2 The house is timber-framed, is supported on a piled concrete ring foundation, and is of a simple shape in plan and form. The sloping roof is clad with painted corrugated iron and has projecting eaves. The exterior walls are generally clad with rusticated Douglas Fir bevel-back weatherboards and the north elevation of the lower level is clad with plywood sheet. The external joinery is of a light weight aluminium construction.
