Determination 2013/020

The refusal to issue a code compliance certificate for a 16-year-old garage at 25 David Crescent, Karori, Wellington

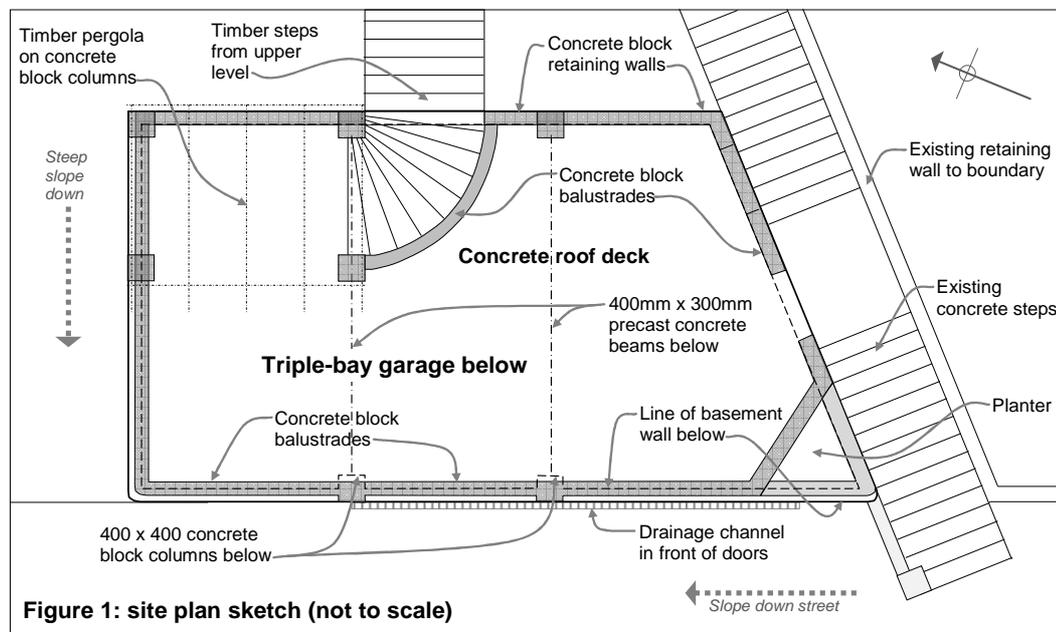
2.1 The building work consists of a single-storey detached garage set into the face of a steep west-sloping site in a very high wind zone for the purposes of NZS 3604⁴. The garage provides parking for three cars, with a concrete slab and foundations, reinforced masonry retaining walls to three sides, and a concrete roof slab above as shown in Figure 1.
