Determination 2013/038

The compliance of remedial work proposed for the skillion roofs of a house at 1134 Glenorchy/Paradise Road, RD1, Glenorchy

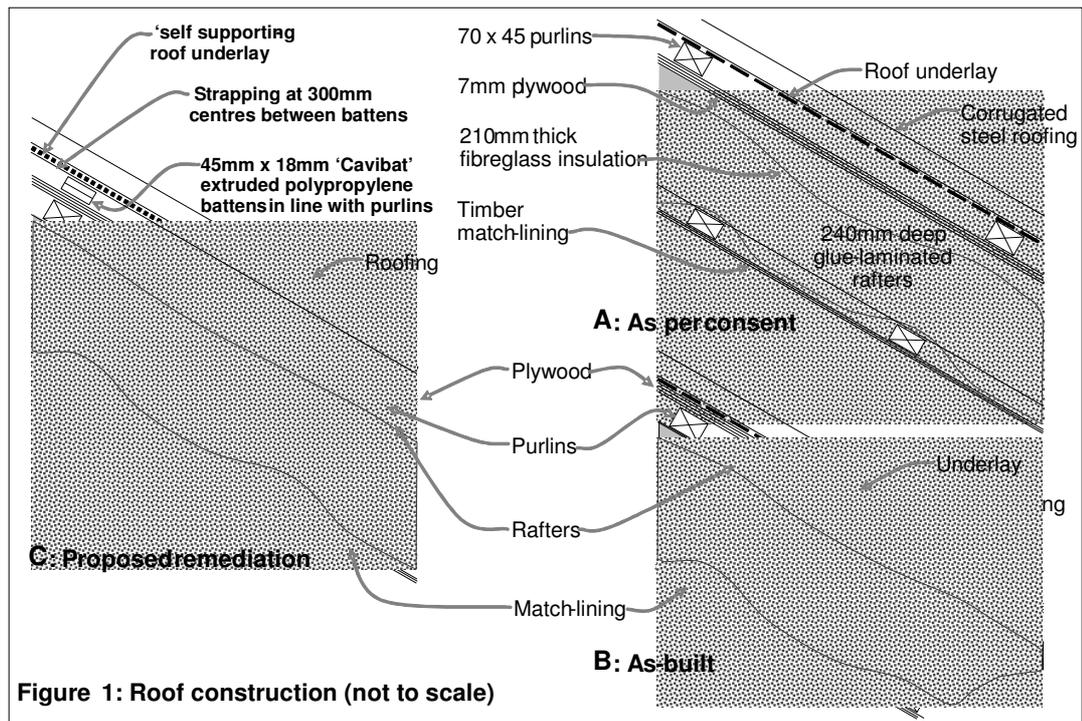
Figure 1: Roof construction (not to scale)

2.3.1 The roof as constructed varies from the consent drawings (refer Figure 1, which also shows the amendments proposed for the roof). The constructed roof varies from the details in the consent drawings in the following ways:

- Detail A: the consent drawings
 - The roof framing drawing calls for 7mm thick plywood ‘over all roof rafters’ (although plywood is not shown in larger scale roof details).
 - Manufacturer’s information for the specified fibreglass insulation provides a ‘nominal stabilised thickness’ of 210mm, which should allow an air gap of about 30mm between the 240mm deep rafters.
 - Heavy weight self-supporting roofing underlay over 70mm x 45mm purlins at 900mm centres provides an air gap between the purlins.
- Detail B: the constructed detail
 - Plywood is fixed to the roof purlins.
 - Blocking is added above the rafters between the purlins, limiting cross-ventilation beneath the plywood.
 - Fibreglass insulation generally fills the cavity beneath the roof purlins.
 - Roof underlay is laid directly over the plywood, with no underlying air gap beneath the underlay.

2.4.1 The proposed roof detail is shown in Detail C; the work adds

- proprietary polypropylene battens, with an open ventilated structure, fixed over the plywood into the roof purlins
- new self-supporting roof underlay laid directly over the battens, with strapping at 300mm centres to prevent sag reducing the underlying air gap
- fixings to existing roof cladding to be 20mm longer to accommodate battens
- new ventilated ridge cappings installed to both gables
- new soffit vents installed to ensure ventilation.
