Determination 2013/066

Regarding the refusal to issue a code compliance certificate due to concerns about compliance of weatherboard fixings to a house at 38 Ostend Road, Waiheke Island

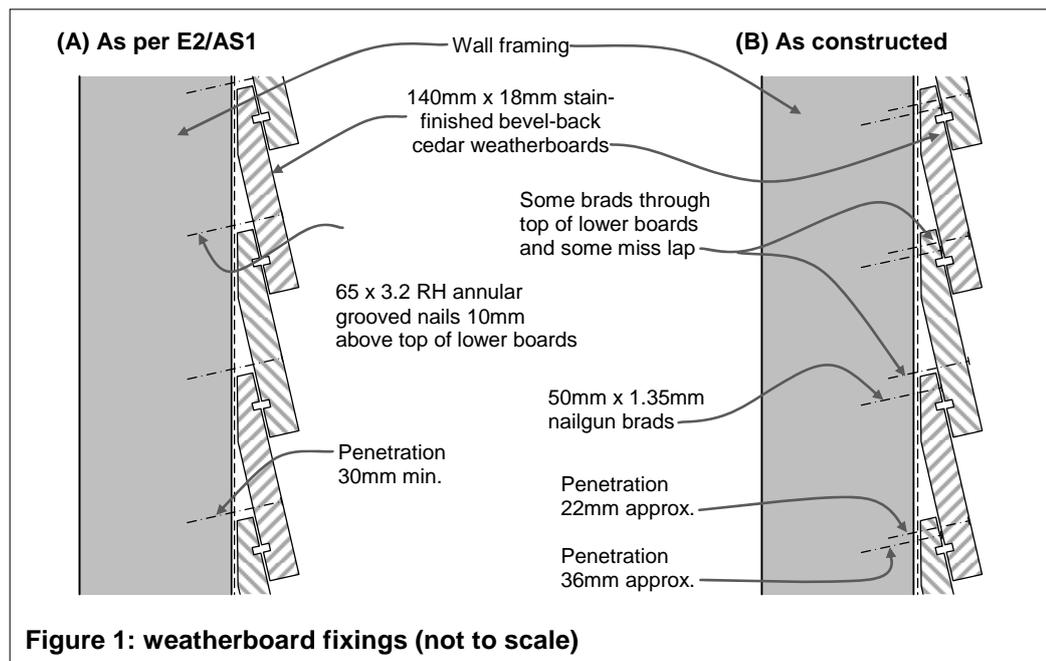
- 2.4.2 The architect’s as-built sketch submitted to the authority (see paragraph 3.4) indicated two adjacent ‘60mm stainless steel senco pins’, with both penetrating the framing by 40mm. However, the expert’s investigations show that the installed weatherboard fixings are as indicated in the sketch in Figure 1(B).

- 2.4.3 As shown in Figure 1 (over page):
- Sketch (A): the Acceptable Solution E2/AS1 calls for rosehead grooved nails that miss the lower board and penetrate into framing by a minimum of 30mm.

- Sketch (B): the installed fixings consist of 50mm nail gun brads to the top and bottom of each board, with nails to the top of each board penetrating the framing by about 36mm and the bottom nails penetrating into the framing by about 22mm. Some of the bottom nails penetrate through the top of lower boards while some miss the lap, meaning that each board has 2 or 3 nails.

- nails are 50mm x 1.35mm stainless steel nail gun brads, with a small head and a smooth shank without grooves
- the board is nailed top and bottom, with the bottom nail to the left penetrating through the lap of the board below.

- Each board has 2 to 3 nails into each stud (depending on how many bottom nails penetrate underlying laps), with the initial nail into the top of each board penetrating the stud by about 36mm (compared to the recommended 30mm).

- The increased number of nails per board together with increased penetration of the top nail is likely to compensate for the smooth shanks and small heads of the nail gun brads.

- additional support to the ends of the weatherboards at the crank in the wall, in a similar manner to that provided by the scribes at the doors

- a detailed proposal accurately showing the actual weatherboard fixings and the proposed additional support to the ends of the boards at the crank in the wall.
