Determination 2014/022

Regarding the refusal to issue a code compliance certificate for 16 to 18-year-old alterations to a house at 60 Nevay Road, Wellington

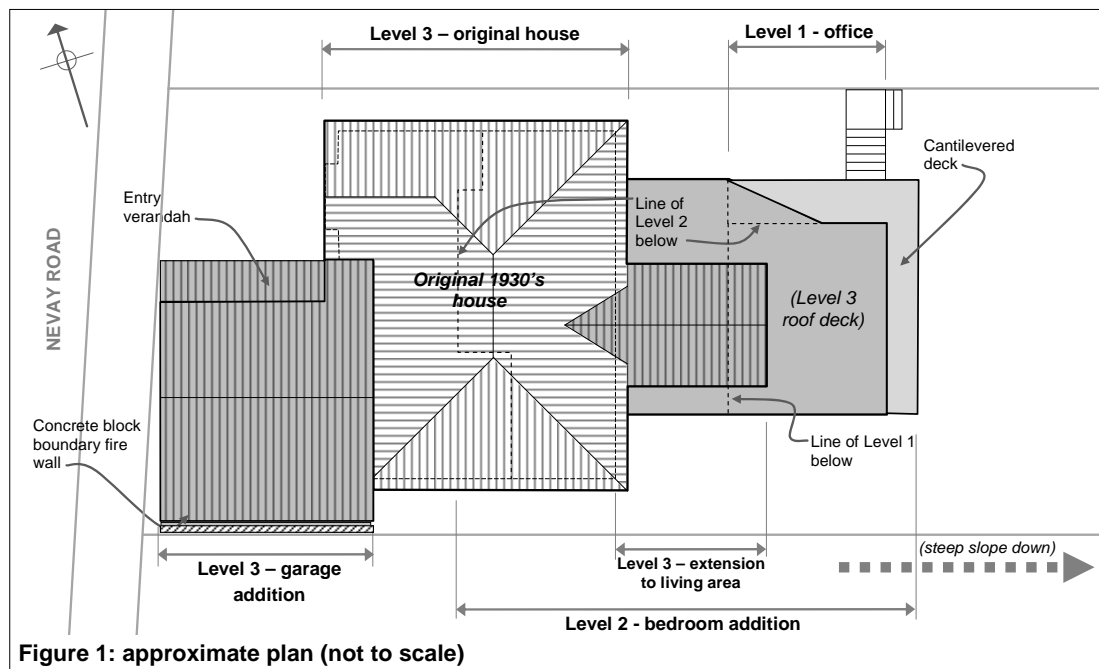
2.3.2 The resulting house is shown in the site plan sketch in Figure 1 above:
