Determination 2014/024

Regarding the issue of a notice to fix for building work carried out to remove a retaining wall at 107 Wharf Street, Tauranga

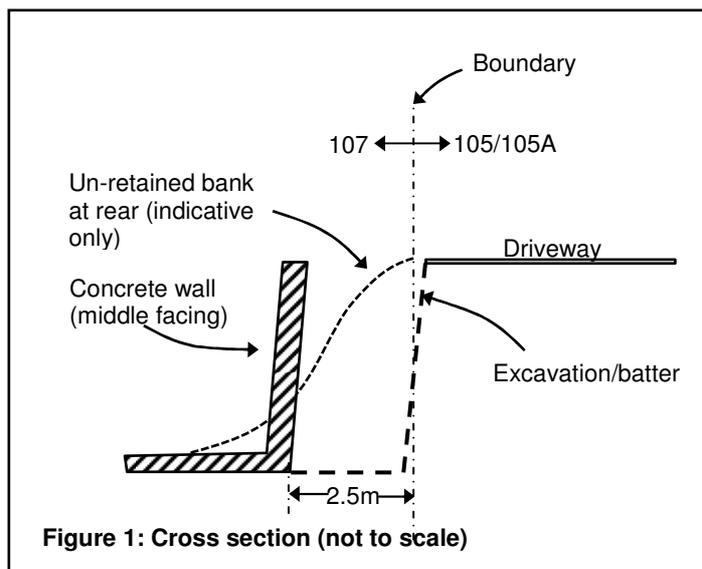
- 2.4.2 Undated photographs provided by the applicant, taken some time after the excavation show the extent of the excavation, some damage to the edge of the adjacent driveway and a temporary plastic netting barrier constructed along the top of the batter.
- 2.4.3 Photographs dated 7 May 2013 show a wooden fence constructed along the top of the batter with a wooden buffer rail installed on the driveway approximately 300mm out from the fence (refer also paragraph 4.13.10).
