Determination 2014/036

Regarding the compliance of building stability at 391E Karori Road, Wellington

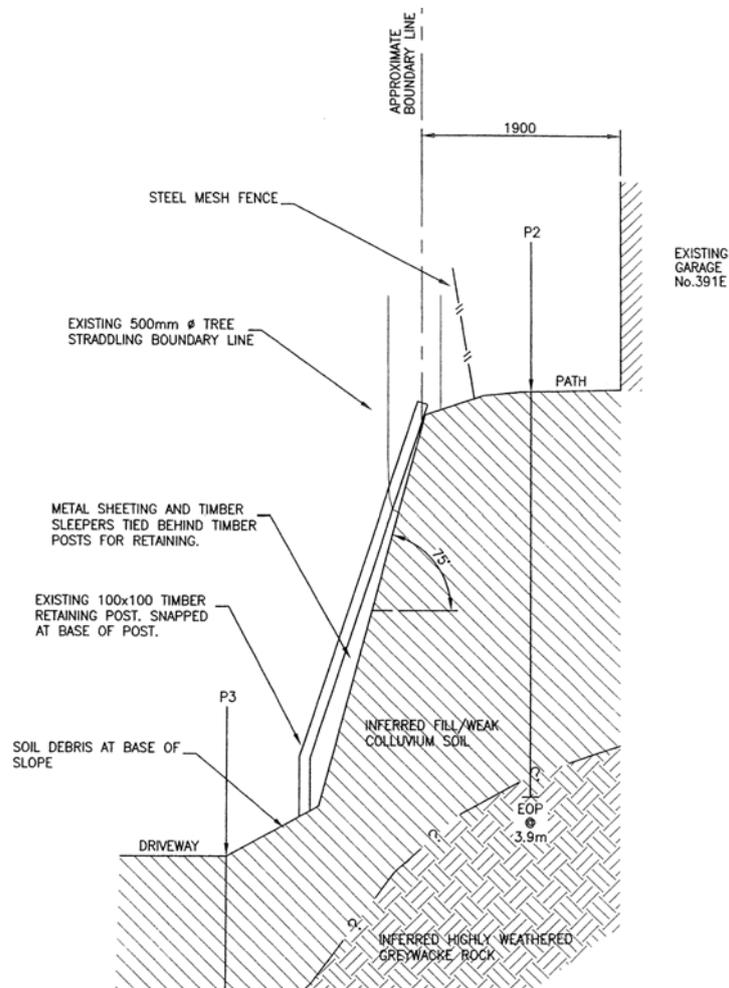
Figure 1: Section through bank to south west of garage

- 2.3 The consent documents include two Producer Statements - PS1 - Design: one is for seven steel beams supporting the upper level to the house, and the other is for alterations to the bracing schedule. Neither PS1 required specific site inspections by the engineer.
- 2.4 The site is a relatively flat subdivided section above Karori Road. The dwelling has been built at the rear (southern) of the section so that its back wall is approximately 3 metres from the site's southern boundary and its side wall (also the garage wall) is 1.9 metres from the western boundary.
- 2.5 A steep bank of up to approximately 3 to 4.5 metres in height and at approximately 70° to 80° to the horizontal⁴ runs along this western boundary, dropping down to the neighbouring property at 399 Karori Road (the neighbouring property), refer

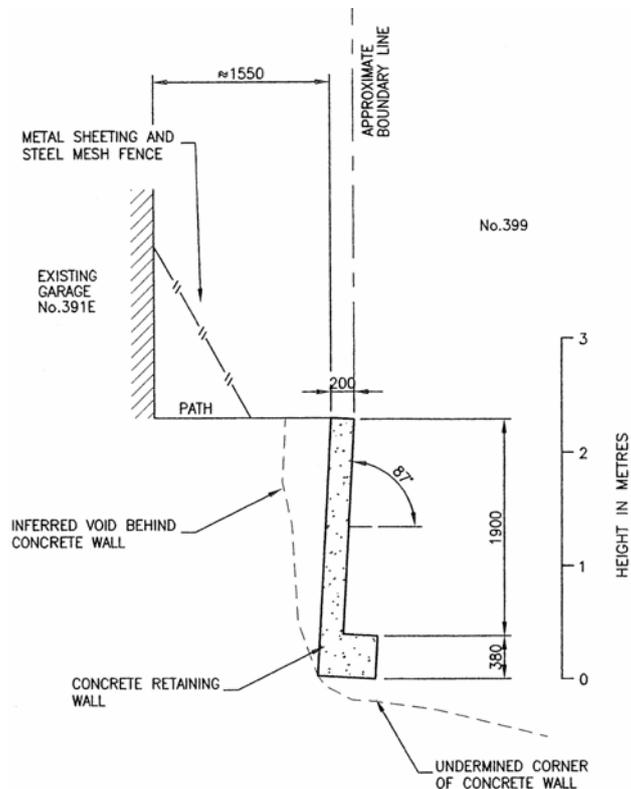
Figure 1. The bank transitions to a steep slope towards the north and to a raised garden and leaning concrete wall at the corner of the boundary to the south (refer Figure 2).

Figure 2: Section through bank to south east of garage

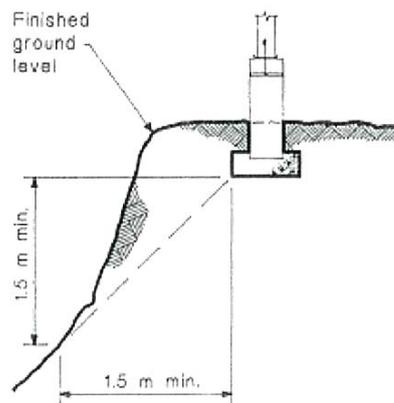
**Figure 3.1 'Relationship of foundation to sloping ground surface'
(from NZS 3604:1990)**

- The plans showed the building set back 2.2m from the western boundary and 3.3m from the southern boundary. The design complied with Clause 3.1.1(c) of NZS 3604:1990 which, amongst other things, required Figure 3.1 to be satisfied. In the absence of other evidence as to site instability, there would have been no reason for the authority to seek further information about site stability.

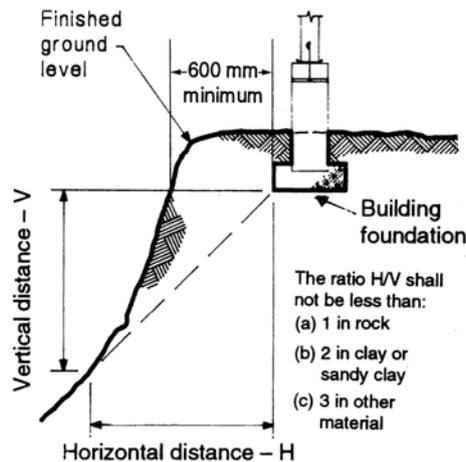
**Figure 3.1 'Relationship of foundation to sloping ground surface'
(from NZS 3604:1990, Amendment 1, 31 July 1992)**

- 4.3.2 The authority is of the view that the foundation satisfies Clause 3.1.1 and Figure 3.1 from NZS 3604:1990 (refer paragraph 4.2.2, 4th bullet). However, Figure 3.1 was amended in 31 July 1992 to that shown above. As piles were required by the authority, the ground under the foundations was unlikely to be considered rock at the time of inspection. Assuming the ground is at best 'clay or sand clay', the bottom of the foundation is to be supported on ground defined by a 1:2 line taken from the bottom of the foundation. At the time of construction I consider the bank did not provide this ground support.
