Determination 2015/063

Regarding the refusal to issue code compliance certificates for two adjoining houses with monolithic cladding at 23 Winifred Street, Okitu, Gisborne

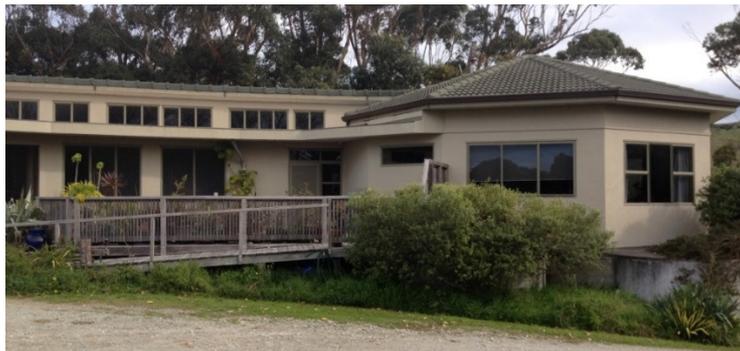
Figure 1: East elevation of House A
