Determination 2016/027

The refusal to issue a code compliance certificate for 14-year-old alterations to plaster-brick house at 526 Ellesmere Road, Ladbrooks, Christchurch

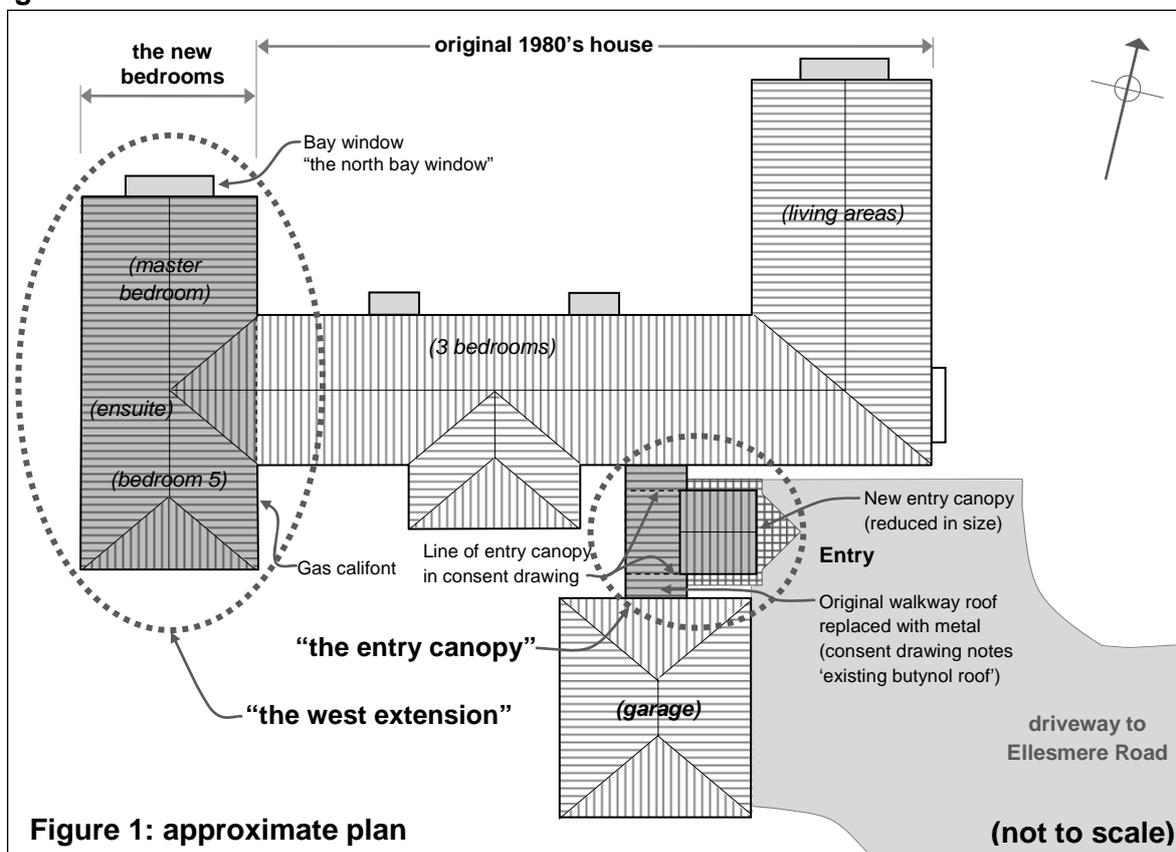
Figure 1

2.3 The addition extends the original house as shown in Figure 1; using the same form and materials as the original house. Except for a 150mm verge overhang to the north gable end to match the original north elevation, the 45° pitch roof to the west extension has no eaves or verge overhangs.

2.4.1 The west extension forms a new bedroom wing and the alterations to the existing house include the construction of a new entry canopy to the original covered walkway on the east elevation. The two areas of new building work are shown shaded in Figure 1.
