Determination 2016/048

Regarding the requirements under section 112 to remediate the fire separation between units in an apartment complex, and the compliance of the proposed solution at 287 – 289 Shirley Road, Papatoetoe, Auckland

Summary

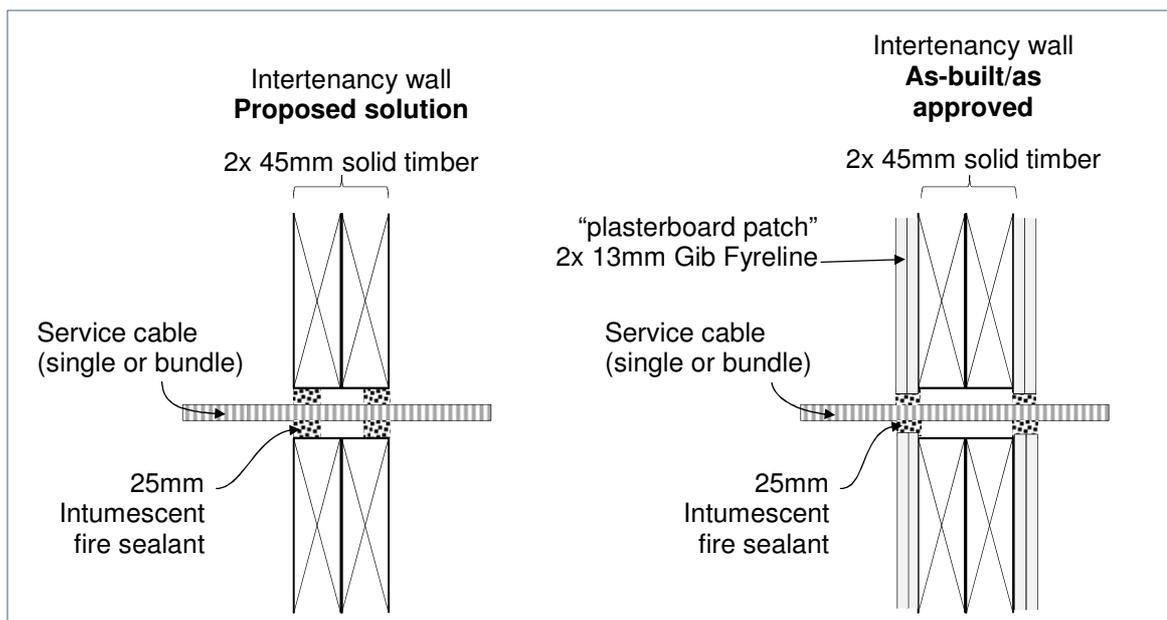
Figure 3: cross section of intertenancy wall (not to scale)

2.5.1 The authority responded on 30 June 2015, stating that it considered the proposed solution was not acceptable because no testing had been done of intumescent fire sealant protection applied directly to timber framing, and in its view ‘a 150 x 150 mm [plasterboard] patch would meet the [plasterboard manufacturer’s manual] where details show plaster board extending 75mm out from a penetration.’ (From the photos of the cable penetrations provided by the applicant, many penetrations are close to the edge of timber member concerned, and the 75mm extension sought by the authority is not able to be achieved.) Refer to figure 3 below:

1. Where the penetration is into bare timber, install a layer of plasterboard around the penetration ...
 2. For cable and metal pipe penetrations, seal any gaps around the cable/pipe with fire-rated mastic, installed to comply with the manufacturer's instructions. Not (*sic*) in particular the minimum depth/thickness of sealant that must be achieved.

3. For plastic pipe, install an appropriately sized intumescent collar in accordance with the manufacturer's instructions.
 4. Not (*sic*) the location and type of all penetrations on as-built drawings.
