Determination 2017/035

Regarding the refusal to issue a code compliance certificate for an 18-year-old house at 1135 Telegraph Road, Darfield

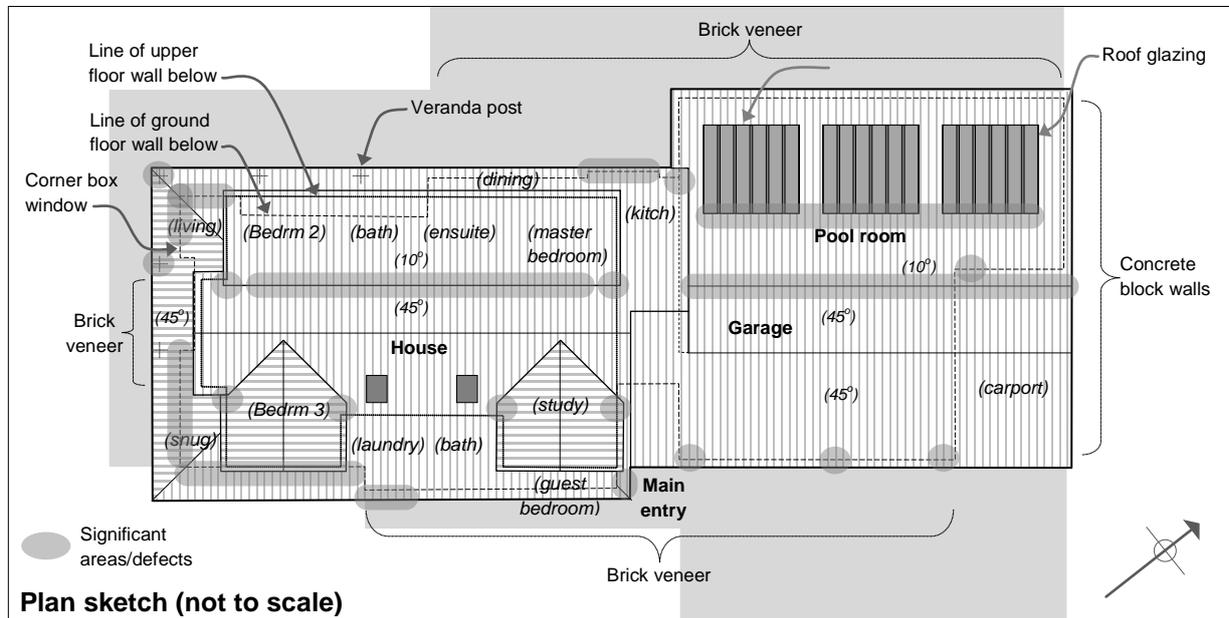
Figure 1: Approximate plan

- 2.1 The building work consists of a two-storey four bedroom house with an attached single-storey garage/pool room as shown in Figure 1. The house is situated on a large level rural site in a high wind zone for the purposes of NZS 3604⁴ and is assessed as having a moderate to high weathertightness risk (see paragraph 7.2).
- 2.2 Construction is generally conventional light timber frame, with concrete foundations and floor slab, plastered brick veneer and concrete block wall cladding to parts of the lower level, timber weatherboards to the remaining walls, aluminium windows and profiled metal roofing.

- 2.4.1 As shown in Figure 1, roofs are a mix of gables, hipped lean-tos and monopitch sections. The 45° pitch main roof includes two gabled dormers to the southeast and a raised section of roof above the northwest bedrooms where the roof is a 10° monopitch. The northwest roof to the garage/pool room also changes from a steep pitch to a low pitch, with skylights installed within the 10° pitched roof above the pool room.
- 2.4.2 The main roof generally has eaves of about 400mm overall, while the northwest 10° monopitch roofs and the dormer roofs have no overhangs. On the lower level, the eaves increase to more than 1.1m deep at veranda areas beneath the lean-to roofs, with no verge overhang at the northeast end. The upper walls of the northeast elevation have no verge overhangs and the carport is recessed beneath the roof at the east corner.

- 2.5.1 The brick veneer over cavity and reinforced concrete blockwork walls are shown in Figure 1. Exterior surfaces of the door-height brick veneer and the 2.4m high concrete block walls are plastered and painted. The concrete block walls are recessed at the east corner carport and extend to form the interior wall between the pool room and the garage.
- 2.5.2 The remaining ground floor walls and all upper level wall areas are clad in rusticated cedar weatherboards. The stain-finished boards are fixed horizontally over the building wrap directly to the framing.
