Determination 2017/044

Regarding the refusal to issue a code compliance certificate for a 14-year-old house at 74 to 76 Voyager Drive, Gulf Harbour, Auckland

Summary

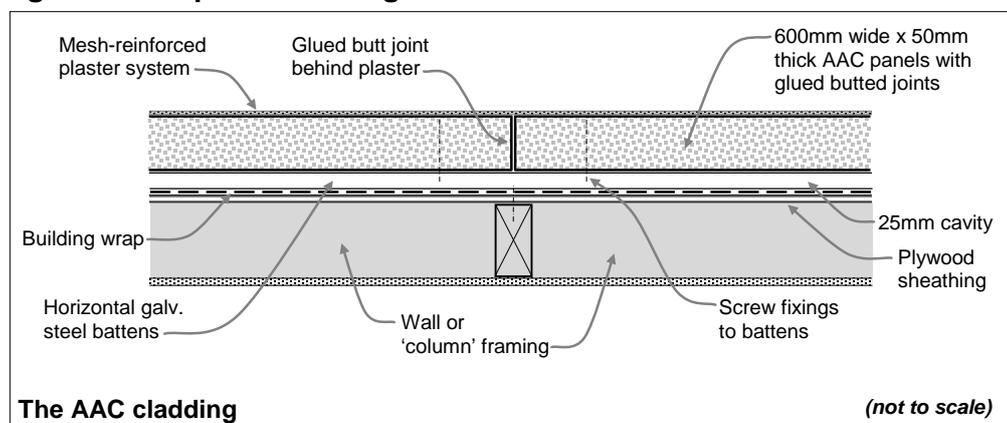
Figure 2: The panel cladding

- 2.5.1 The primary wall cladding is a proprietary monolithic cladding system, with 75mm thick steel reinforced AAC⁶ backing panels finished with a proprietary mesh-reinforced plaster system to form a monolithic finish. Horizontal galvanised steel battens with a ‘top hat’ profile are fixed through the building wrap to the framing and form a 25mm cavity behind the AAC panels. Panels are screw-fixed to the battens, with glued butt-joints as shown in Figure 2, except where control joints are installed.

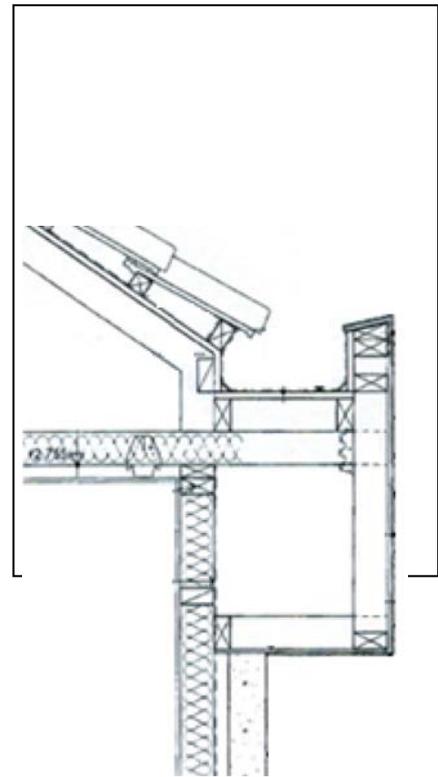
Figure 3: Framed parapet 'beam'

2.5.4 The wall cladding to the framed parapet 'beams' is a form of monolithic cladding, which consists of 7.5 mm thick fibre-cement sheets fixed through the building wrap directly to the parapet framing, and finished with an applied textured coating system to match the panel cladding finish as shown in Figure 3.

2.5.5 Taking account of the expert's observations; I note that although similar, the as-built parapet detail differs from that shown in Figure 3, in that:

- liquid-applied membrane is used in lieu of butyl rubber membrane⁸
- the textured fibre-cement extends down to form a 20mm drip edge at the soffit
- the lower decorative band is identical in thickness to the upper band.
