Determination 2017/049

Regarding the refusal to issue a code compliance certificate for 11-year-old alterations to a house with mixed cladding at 240 Horndon Street, Darfield

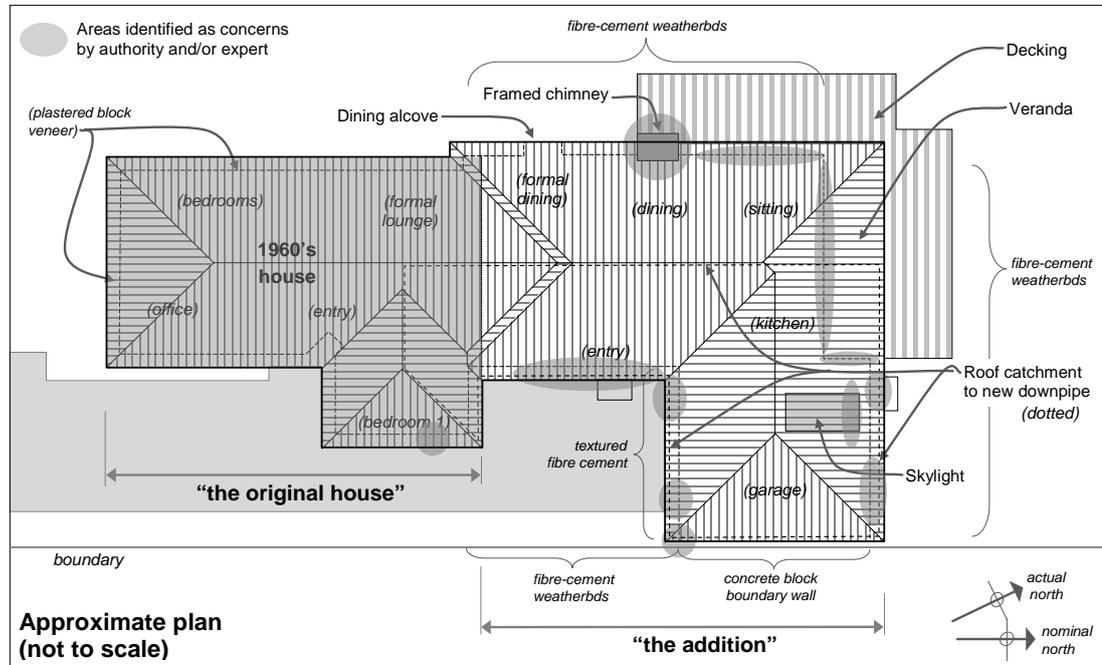
Figure 1: The addition

2.3.1 The subject alterations more than doubled the floor area of the original house by adding about 160m² to the north of the original house as shown in Figure 1:
