Determination 2018/012

The refusal to issue two code compliance certificates for alterations and additions to a house at 433 Marine Parade, Napier

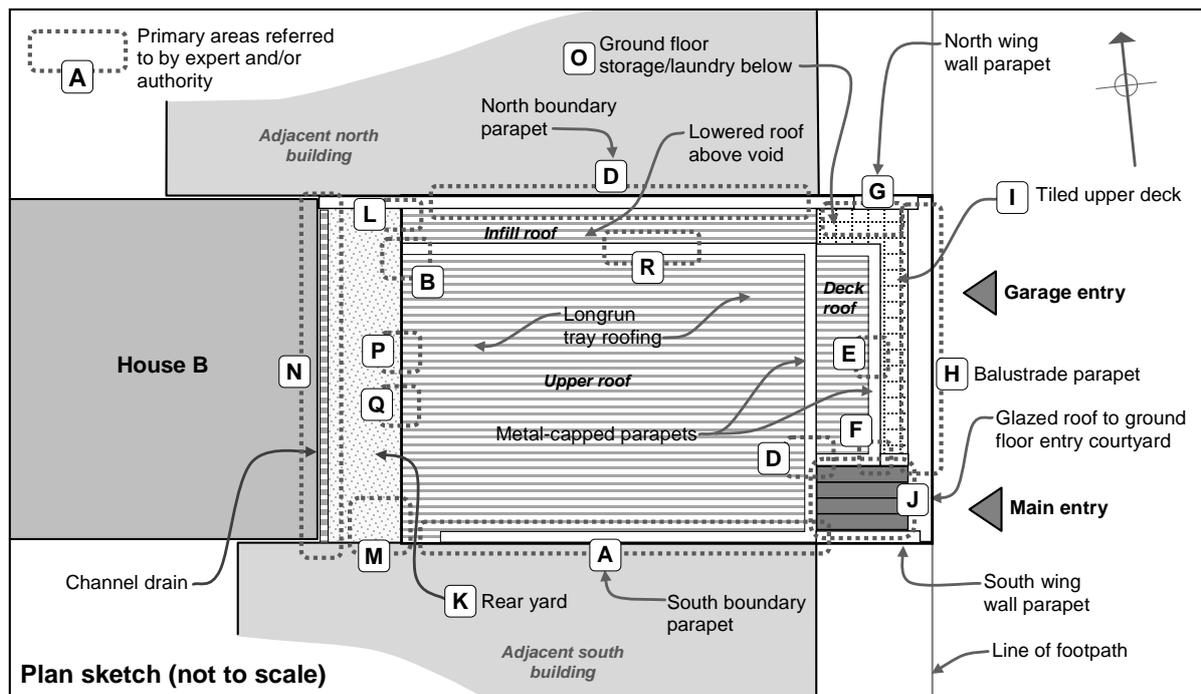
Figure 2: Diagrammatic Roof Plan

1. Parapet capping/wall junction (Area D)
2. Unpainted and cracked fibre cement to roof parapet (Area A)
3. Roof/wall flashing (Area M)
4. Unpainted fibre cement patch to roof parapet above lounge (Area A)
5. Deck posts/deck floor junctions (Area I)
6. Deck post/balustrade parapet junction (Area F)
7. Drainage inspection junction (Area L)
8. Adjacent north building wall/cladding junction (Area L)
9. Cladding crack (Area L)
10. Unsealed pipe penetration to upper west cladding (Area L)
11. Entry roof glazing/adjacent south building wall junction (Area J)
12. Balustrade parapet/north wing wall junction (Area G)

- bottom of the deck columns (Area E and Area F)
- concrete wall/deck tile junction at the north wing wall (Area G)
- flashing to the west end of inter-roof parapet (Area B)
- south boundary wall/roofing junction at the SW corner (Area M)
- cracks to the inter-cladding junction at SW corner (Area M)
- cracked and leaking inter-cladding junction at NW corner (Area L)
- unsealed pipe penetration at the NW corner (Area L)
- the lack of control joints to west wall textured fibre cement (Area P)
- embedded vertical pipe above west gully trap (Area Q)
